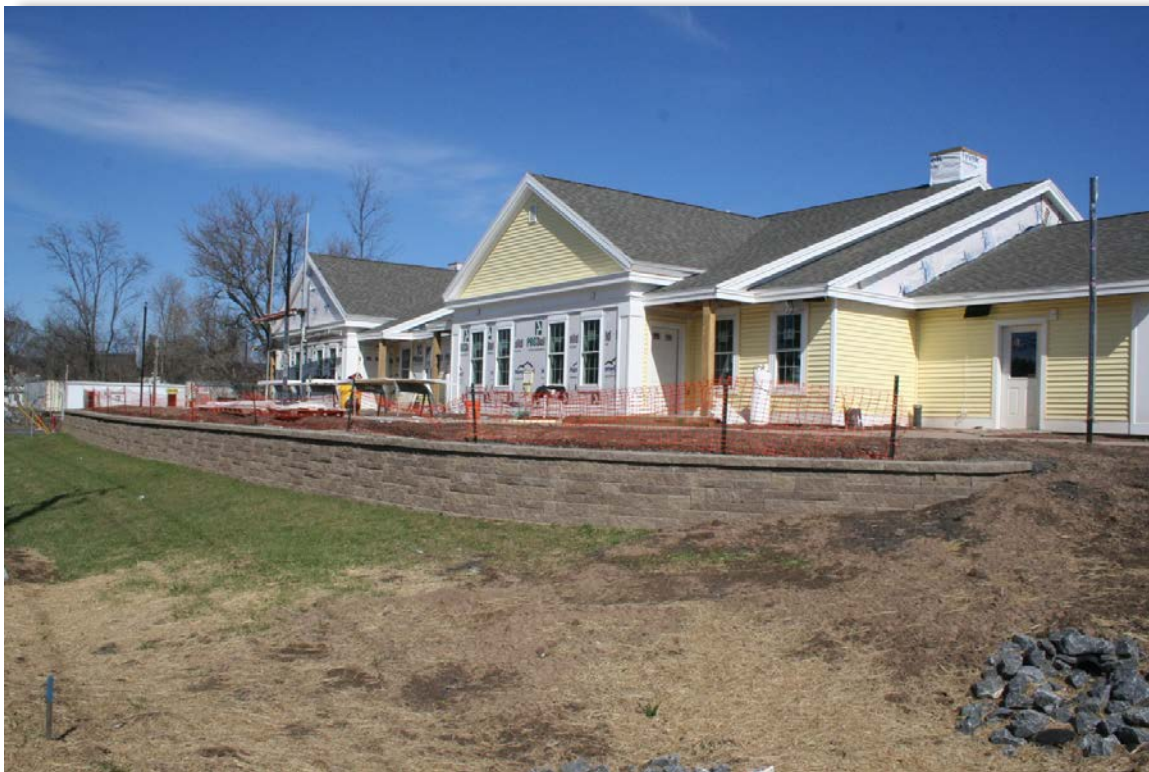
**Figure 4-2**  
**New elevated homes under construction**

Elevation of the structure – Home elevation involves the removal of the building structure from the basement and elevating it on piers to a height such that the first floor is located above the level of the 100-year flood event. The basement area is abandoned and filled to be no higher than the existing grade. All utilities and appliances located within the basement must be relocated to the first-floor level or installed from basement joists or similar mechanism at an elevation no less than 1 foot above the base flood elevation.

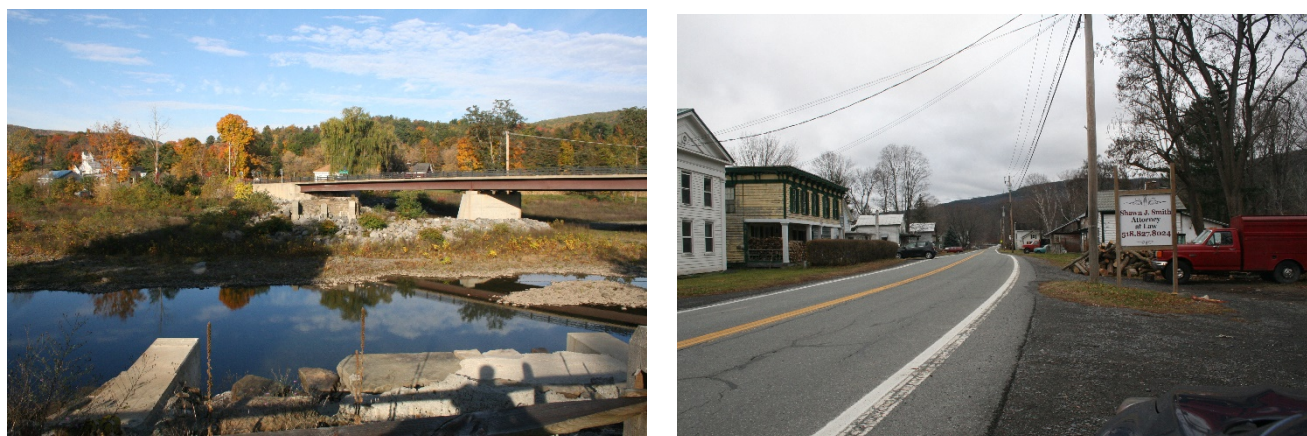
**Figure 4-6**  
**Photos of NY Route 30**

*View of NY Route 30 bridge over Schoharie Creek in North Blenheim, with abutments of the former historic Blenheim covered bridge visible (left photo); view along NY Route 30 through hamlet of North Blenheim (right photo)*

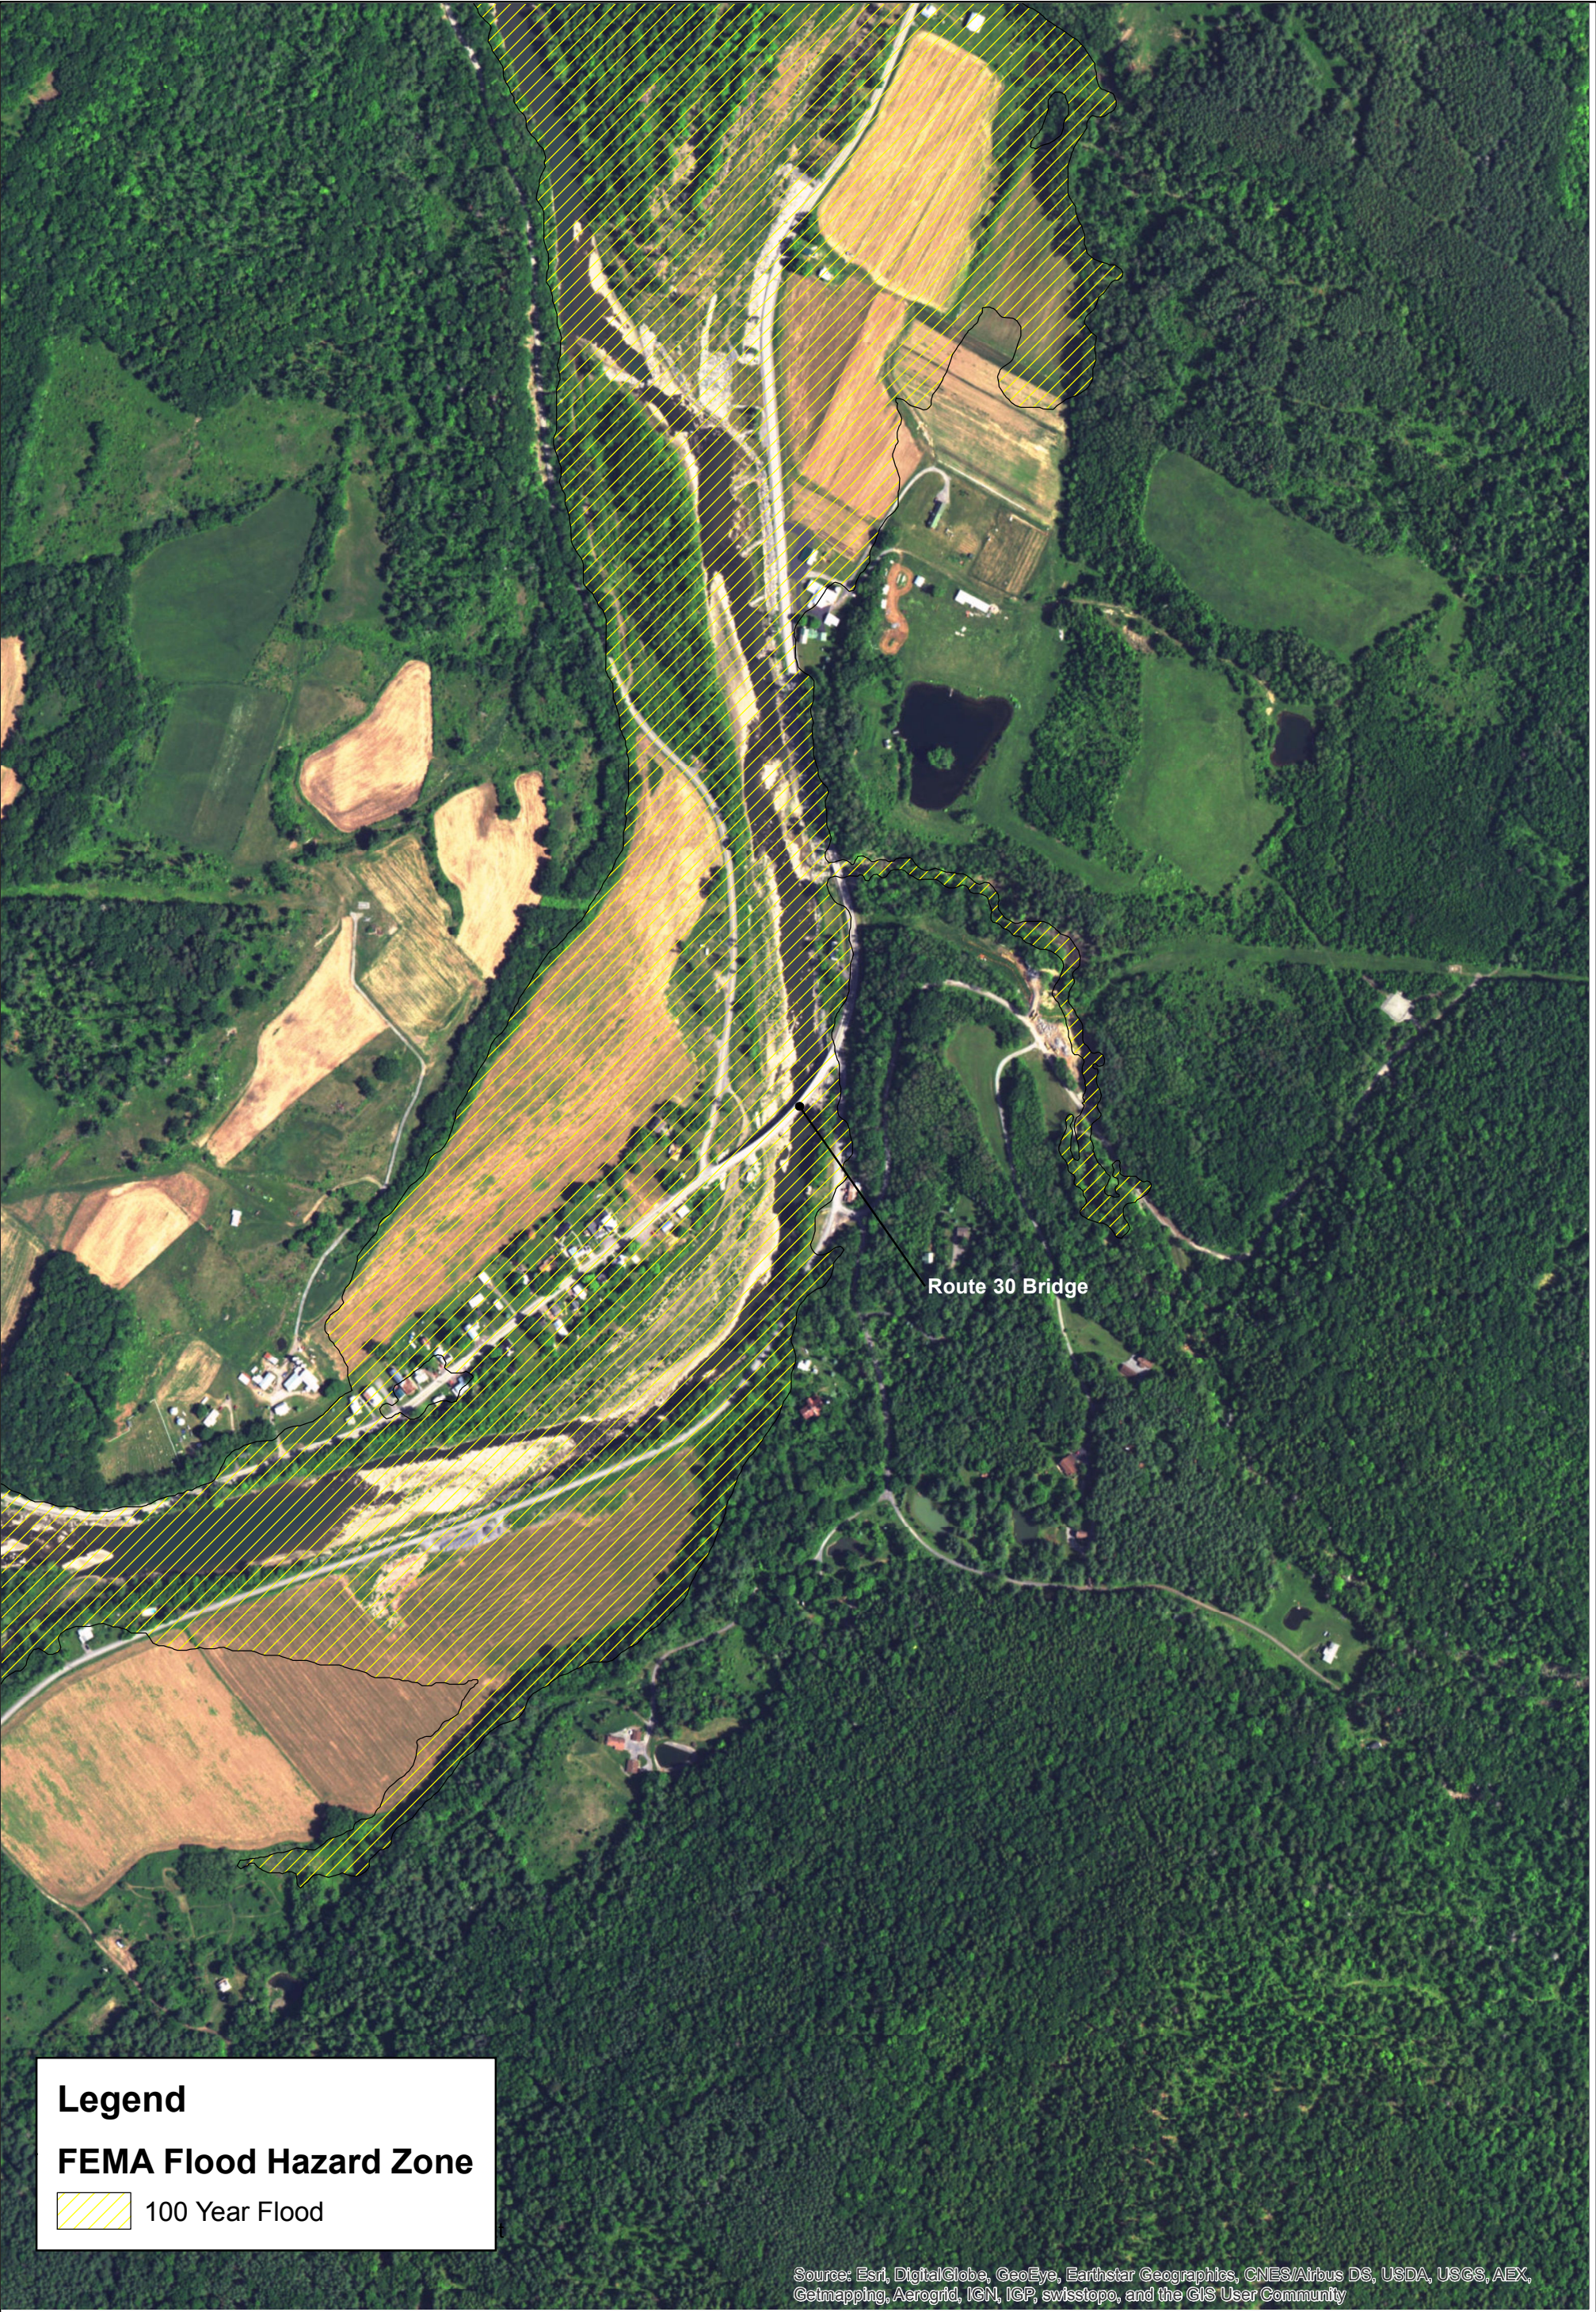
This reach of Schoharie Creek has been evaluated by FEMA using approximate engineering methods only, meaning that identification of areas subject to flooding has been approximated. An existing conditions HEC-RAS hydraulic model was obtained from FEMA. The resulting FEMA FIRM indicates that the 100-year flood event inundates much of the developed area of the hamlet of North Blenheim along NYS Route 30, including the roadway itself (Figure 4-7). A FEMA floodway has not been designated in this reach.

<b>SOURCE(S):</b> NYS GIS Clearinghouse Orthoimagery (accessed June 2016)  FEMA Schoharie County Special Flood Hazard Area		<b>Figure 4-7: FEMA Flood Insurance Rate Map - North Blenheim</b>		<b>Location:</b>  <b>Blenheim, NY</b>	
<div><div></div><div>N</div></div> <b>Schoharie Basin Flood Analysis</b>		<b>Map By:</b> EMH <b>MMI#:</b> 4805-05 <b>MXD:</b> Q:\Projects\4805-05 Schoharie Basin Flood Analysis\GIS\MDX <b>1st Version:</b> 6/6/2016 <b>Revision:</b> 9/22/2016 <b>Scale:</b> 1 in = 540 ft		<div><div></div><div><b>MILONE &amp; MACBROOM</b> 231 Main Street, Suite 102 New Paltz, NY 12561 (845) 633-8153 Fax: (845) 633-8162 www.miloneandmacbroom.com</div></div>

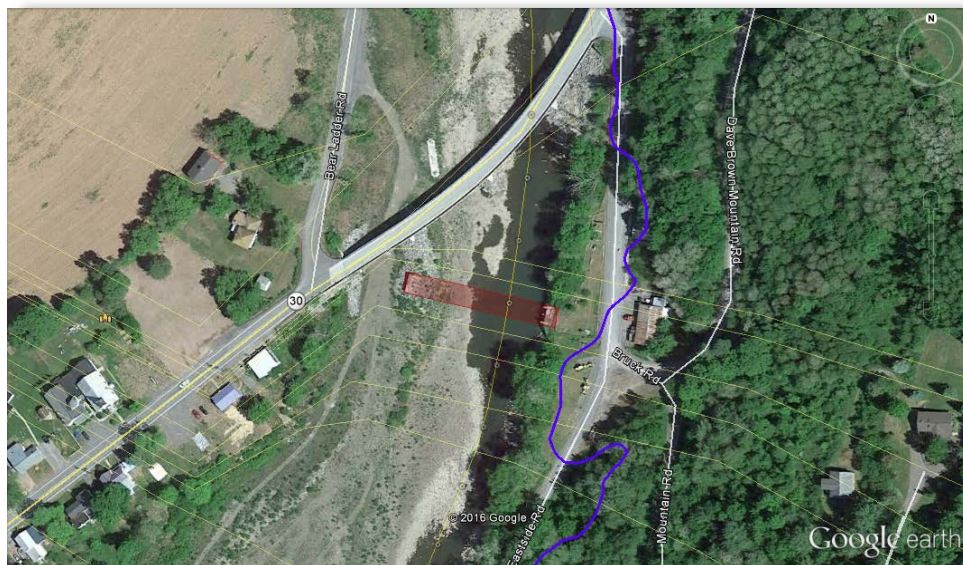
**Figure 4-8**  
**Aerial Photograph Showing Former Location of Blenheim Covered Bridge**

This alternative assesses the impact of the historic Blenheim covered bridge, located just upstream (south) of the NYS Route 30 crossing over Schoharie Creek. Figure 4-8 is an aerial photograph of the bridge site. The timber superstructure of the bridge was destroyed during Tropical Storm Irene and had been damaged during previous flood events. The abutments sustained minor damage during Irene but remained in place after the flood receded. Local interest has been expressed in rebuilding the covered bridge by reusing the existing abutments. As envisioned, the replacement bridge would be a replica of the original bridge, but the deck would be set 10 feet higher than the former deck (Watershed Post, September 18, 2015, and June 23, 2016).

Three alternatives were analyzed to determine the impact of the bridge and its abutments on flooding in the hamlet of North Blenheim. First, an analysis was conducted to determine the impact of the bridge on water surface elevations if the deck were to be replaced at the same elevation as the former bridge deck. Second, an analysis was undertaken to determine whether a replacement bridge with the deck set at an elevation 10 feet higher than the former bridge would cause an increase in water surface elevations that would contribute to flooding in the North Blenheim hamlet. Third, an analysis was conducted to determine whether removal of the existing abutments from the channel would result in a decrease in flood elevations in the hamlet.

Reconstructing the historic covered bridge at the same elevation as the former bridge would cause a 2.8-foot rise in the 100-year flood elevation at the bridge. The rise in water surface elevation would extend approximately 3,500 feet (three-quarters of a mile) upstream of the bridge and would cause increased flooding of structures in North Blenheim and along NYS Route 30 as it passes through the hamlet. The hydraulic opening of the covered bridge, if reconstructed at the same elevation as the former bridge on the existing abutments, would be substantially undersized for the 100-year flood, and floodwaters would

If the replacement bridge were to be set on the existing abutments and raised 10 feet higher than the elevation of the former covered bridge, hydraulic analysis indicates that the new bridge would safely pass the 100-year flood event with adequate freeboard. There would be no rise in water surface elevations at or upstream of the bridge. However, it is important to note that if larger abutments or piers were to be set in the channel, or if a roadway embankment were to be constructed to connect the replacement bridge to the bank on the left side of the channel, an increase in water surface elevations would result.

If the Blenheim covered bridge is replaced, the replacement deck should be set at an elevation that is 10 feet higher than the deck of the former historic bridge. The replacement bridge should be set on the existing abutments or on new abutments that do not occupy more space in the channel than the existing abutments. No roadway embankment should be constructed on the left side of the bridge to connect the bridge deck to the left bank. Detailed hydraulic modeling should be conducted as part of the engineering design to ensure that the new bridge does not cause an increase in water surface elevations at or upstream of the bridge.

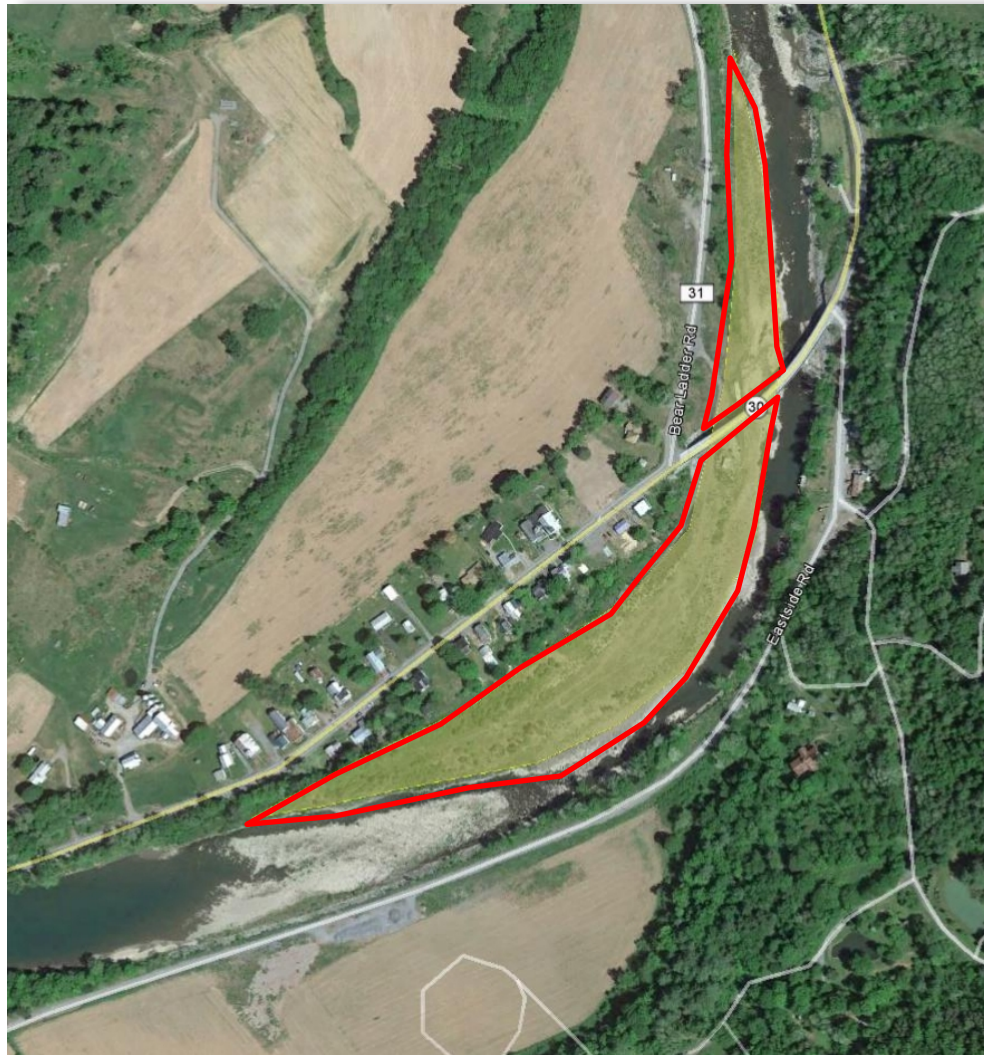
**Figure 4-9**  
**Alternative 1-2a**

Results of the modeling show a drop in the 100-year flood water surface elevations ranging between 2 and 3 feet extending approximately two-thirds of a mile upstream of the bridge. This reduction would lower flood elevations in the hamlet and would result in the elimination of approximately 18 to 20 properties from FEMA's mapped 100-year SFHA.

*Scenario involving construction of enhanced floodplain scenario 1-2a, along the left bank in North Blenheim, near the NYS Route 30 bridge (Shaded area outlined in red represents area of enhanced floodplain.)*

While the removal of these properties from the floodplain would be beneficial, the cost of such a project would be high. Implementation would involve the removal and off-site disposal of approximately 75,000 cubic yards of material and revegetation of the modified areas. This scenario would also require the removal of the existing abutments of the former covered bridge, which is not feasible if the bridge is to be replaced with a new structure as discussed above.

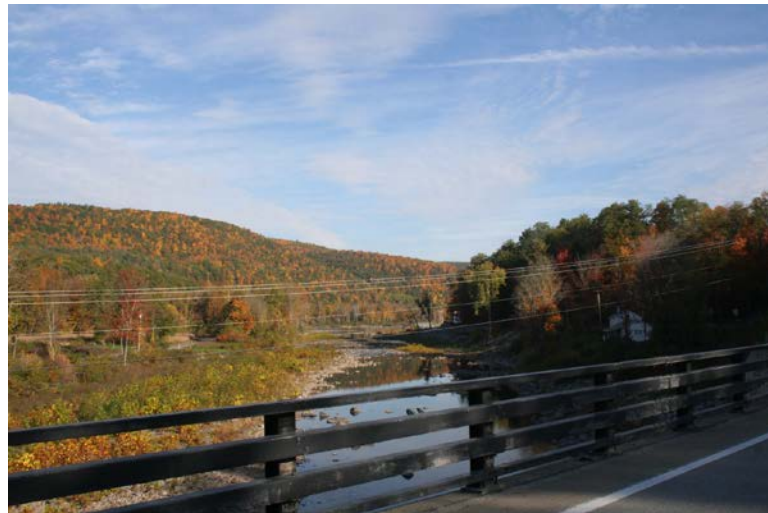
**Figure 4-12**  
**Route 30 Bridge**

*View from NYS Route 30 bridge over Schoharie Creek looking downstream toward location of proposed floodplain enhancement scenario 1-2c*

*Alternative 1-2c* – Based upon an iterative assessment using hydraulic modeling, a reduction in channel of conveyance in the area of the NYS Route 30 bridge was determined to be a hydraulic constriction contributing to a rise in water surface elevations that extend upstream through the North Blenheim hamlet. A floodplain enhancement and sediment removal scenario was assessed in the area of the NYS Route 30 bridge, starting approximately 175 feet upstream of the bridge and extending to 925 feet downstream of the bridge (Figure 4-12). Prior to this scenario being undertaken, further investigation will be necessary to determine whether the removal of the abutments for the former covered bridge would be required or whether they could be left in place (the possible replacement of the historic covered bridge is discussed under Alternative 1-1).

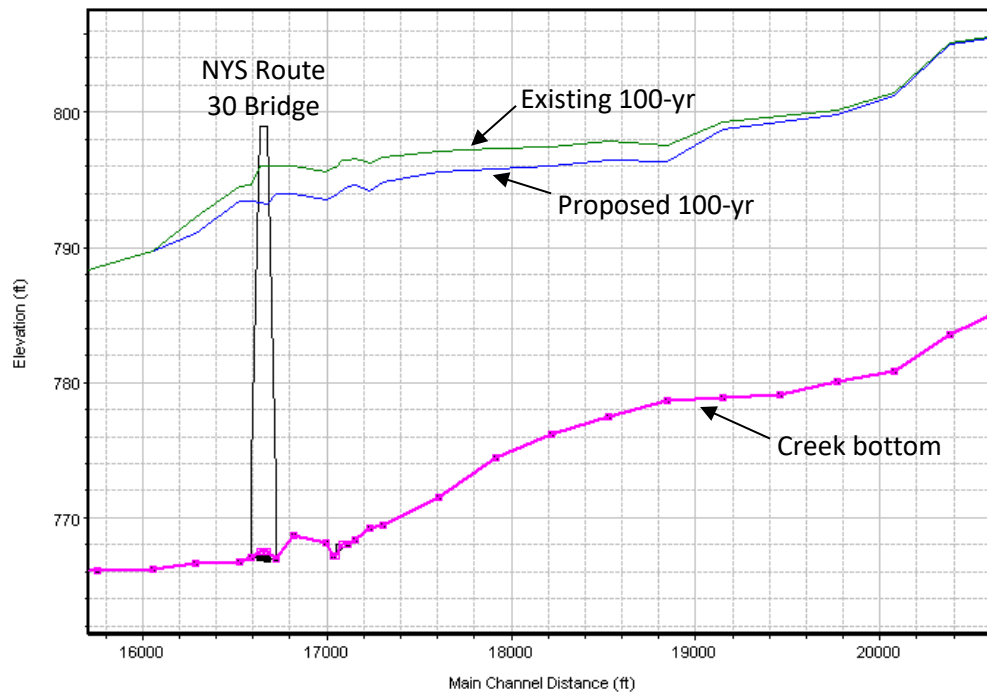
**Figure 4-13**  
**Existing and Proposed Water Surface Elevations for Scenario 1-2c**

*Profile showing existing (green) and proposed (blue) water surface elevations for scenario 1-2c during the 100-year flood event, extending up Schoharie Creek upstream of the NYS Route 30 bridge*

The results of floodplain enhancement and sediment removal scenario 1-2c were found to be effective at lowering water surface elevations by up to 2 feet over a distance of two-thirds of a mile upstream, which includes the North Blenheim hamlet. Figure 4-13 shows the predicted existing (green line) and proposed (blue line) water surface elevations during the 100-year flood event, extending a significant distance upstream of the NYS Route 30 bridge.

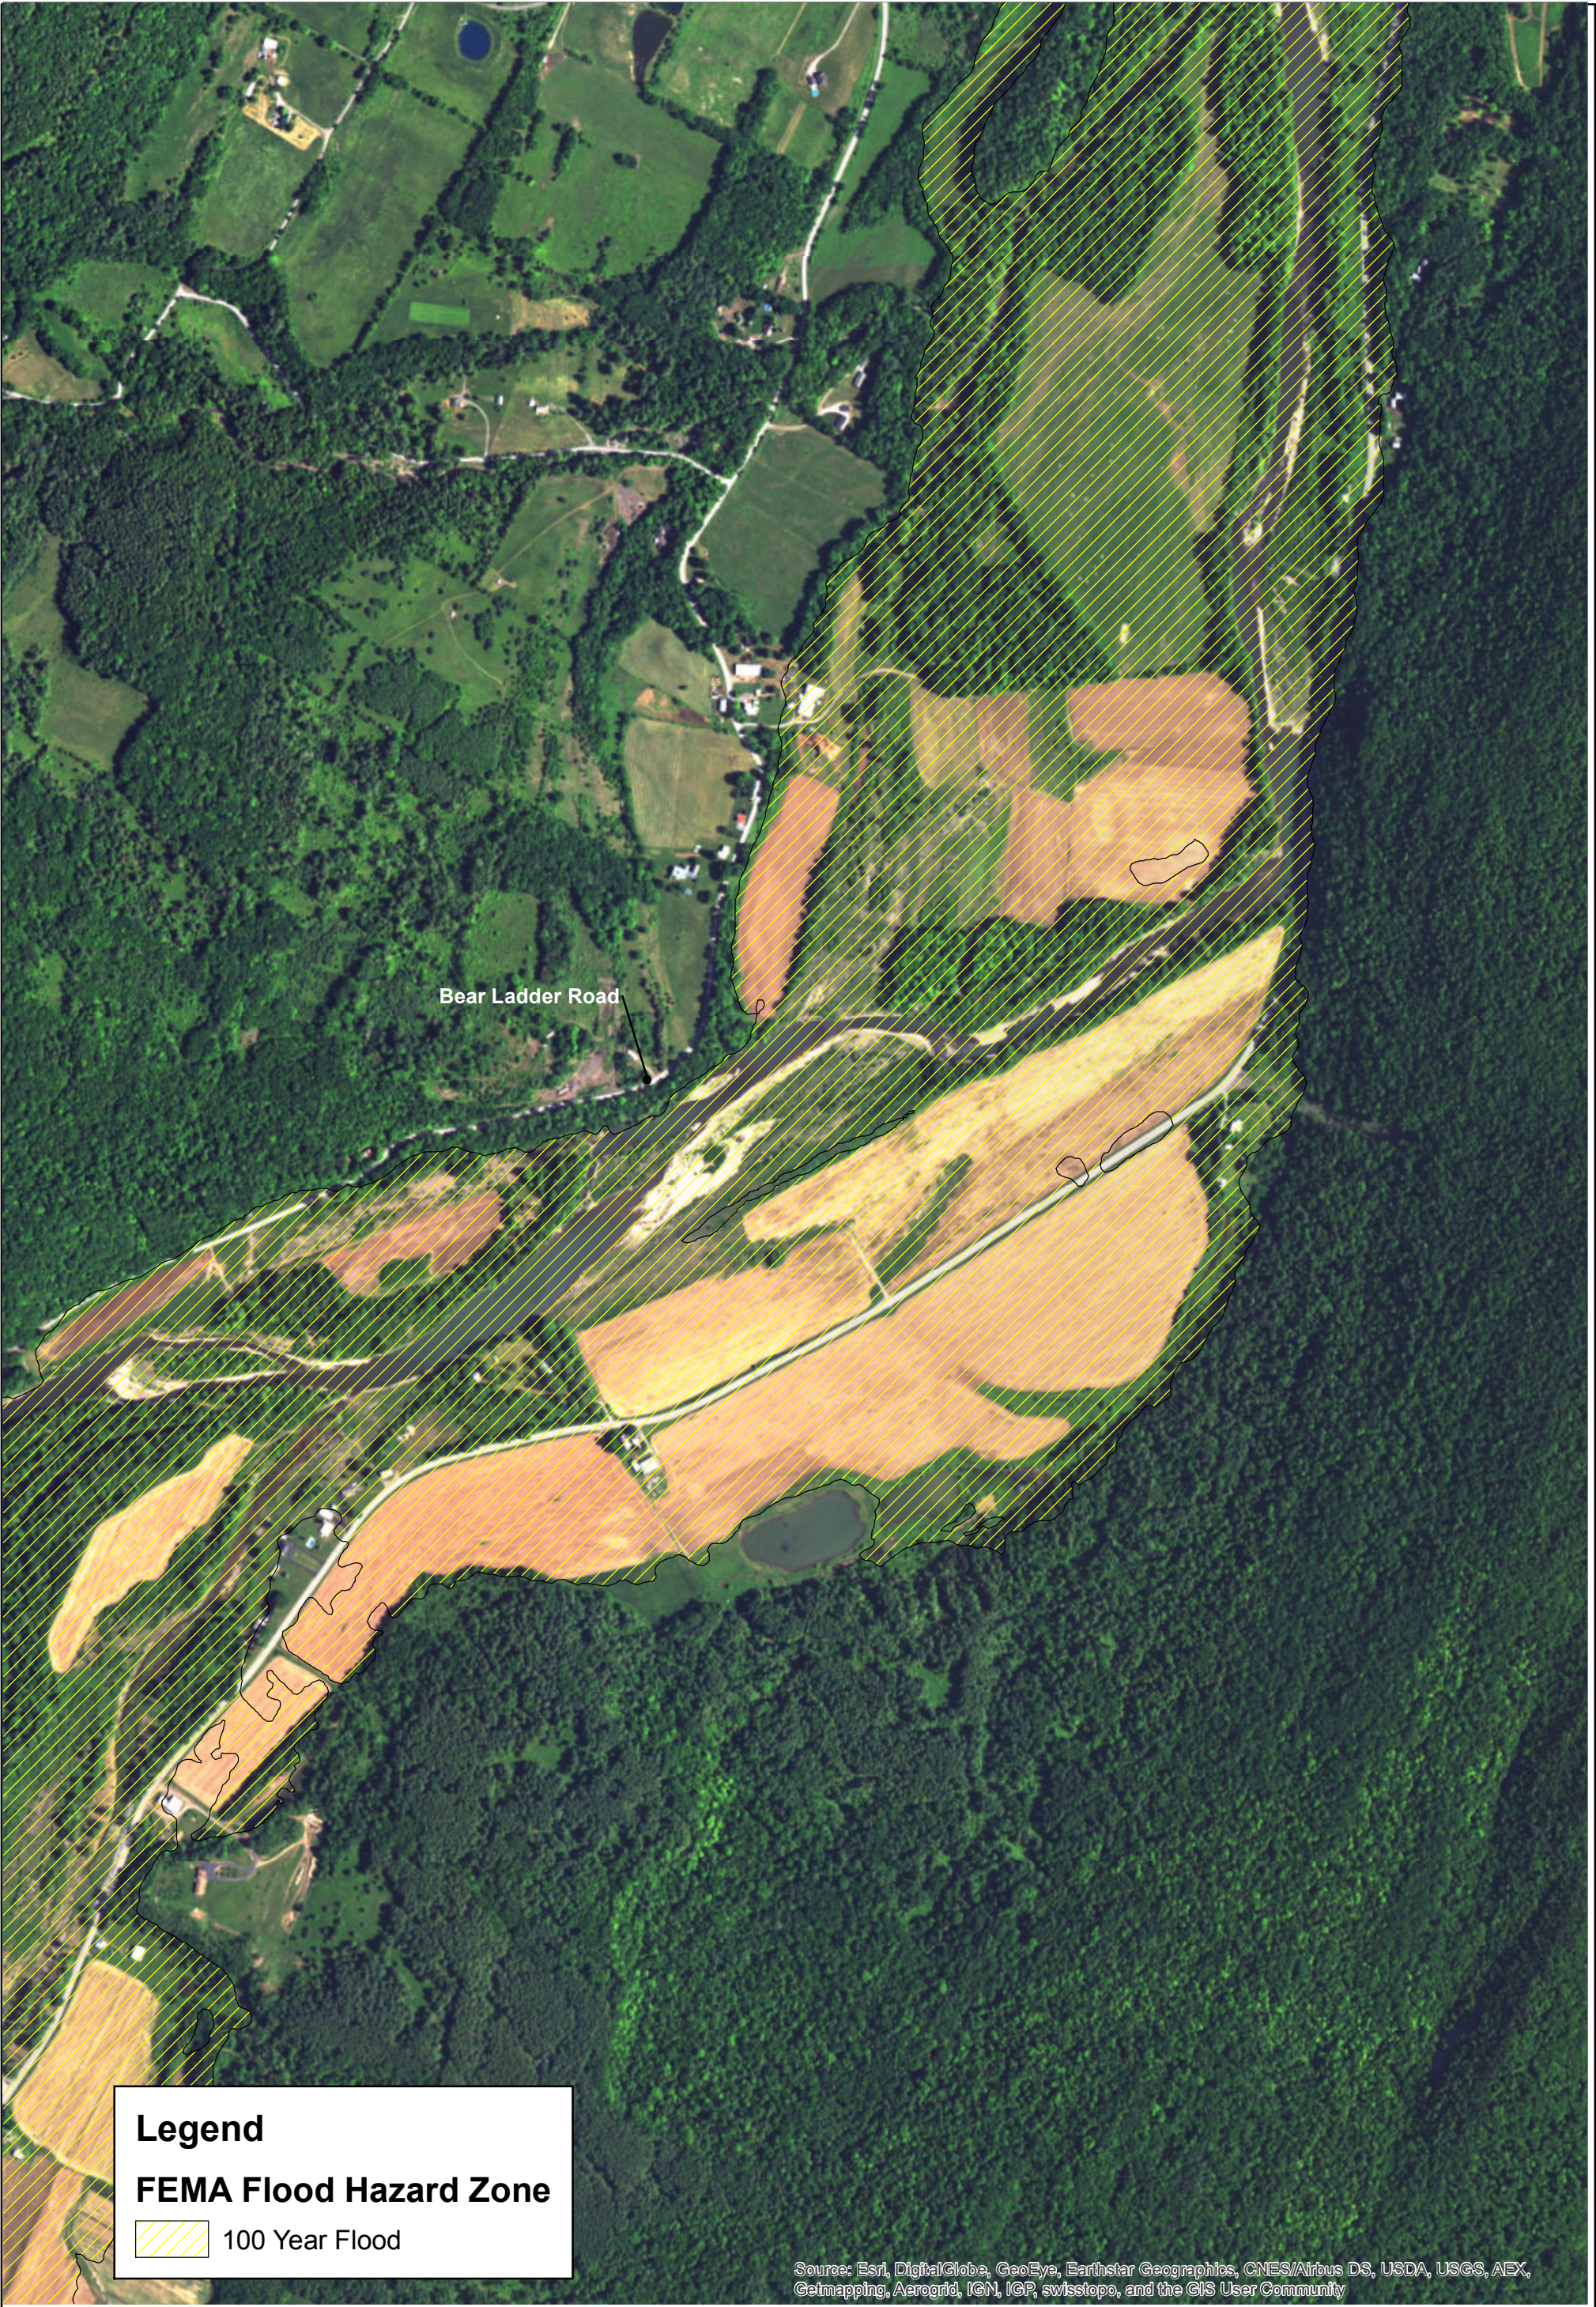
Focus Area #2 is located where Bear Ladder Road (County Route 31) parallels Schoharie Creek, just north of the hamlet of North Blenheim. Frequent flooding is reported at a location approximately 2 miles downstream of the NYS Route 30 bridge coincident with a low spot in the road. When the area floods, travel becomes unsafe or impossible, and access is cut off to several residences. Reports of flooding are consistent with the FEMA 100-year SFHA mapping, which shows Bear Ladder Road overtopping at two separate locations during the 100-year flood event as depicted in Figure 4-15. The more southern area encompasses approximately 2,250 linear feet of road and the more northern about 1,500 feet.

<p><b>SOURCE(S):</b></p> <p>NYS GIS Clearinghouse Orthoimagery (accessed June 2016)</p> <p>FEMA Schoharie County Special Flood Hazard Area</p>		<p><b>Figure 4-15: FEMA Flood Insurance Rate Map - Bear Ladder Road</b></p>		<p><b>Location:</b></p> <p><b>Blenheim, NY</b></p>	
<p><b>Schoharie Basin Flood Analysis</b></p>		<p><b>Map By:</b> EMH</p> <p><b>MMI#:</b> 4805-05</p> <p><b>MXD:</b> Q:\Projects\4805-05 Schoharie Basin Flood Analysis\GIS\MDX</p> <p><b>1st Version:</b> 6/6/2016</p> <p><b>Revision:</b> 9/22/2016</p> <p><b>Scale:</b> 1 in = 675 ft</p>		<p>

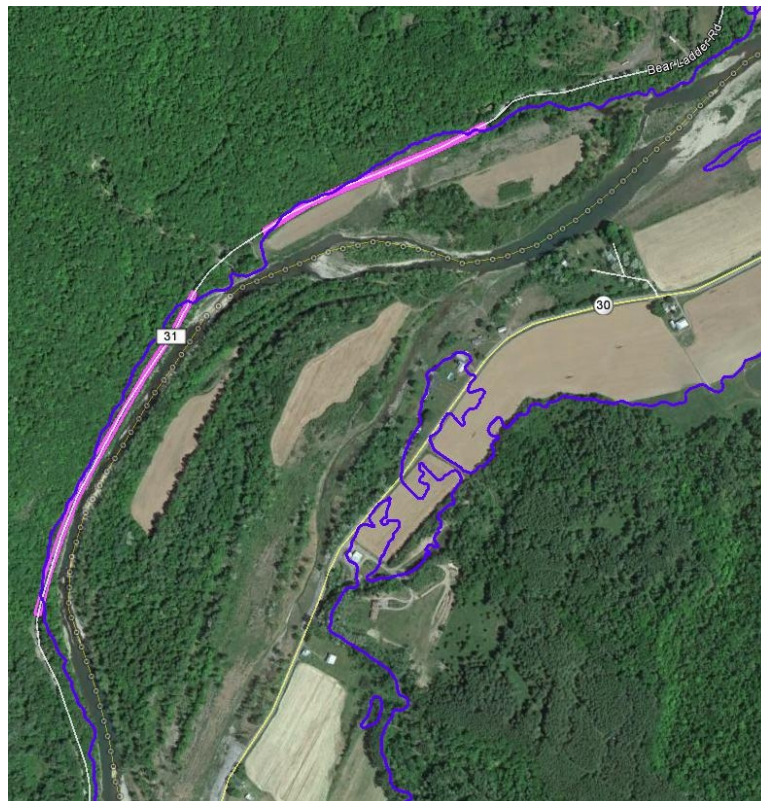
**Figure 4-16**

Hydraulic modeling was undertaken to assess the scenario of raising Bear Ladder Road up and out of the floodplain with 1 foot of freeboard (a factor of safety usually expressed in feet above a flood level) above the 100-year water surface elevation. Raising the roadway was evaluated, assuming a 30-foot embankment and 3:1 side slopes to avoid expensive structural wall construction. The final elevation of the road would need to be increased by 1 to 7 feet, depending on location, over two sections totaling approximately 4,000 linear foot of roadway to effectively protect the road from flooding during the 100-year storm event (Figure 4-16).

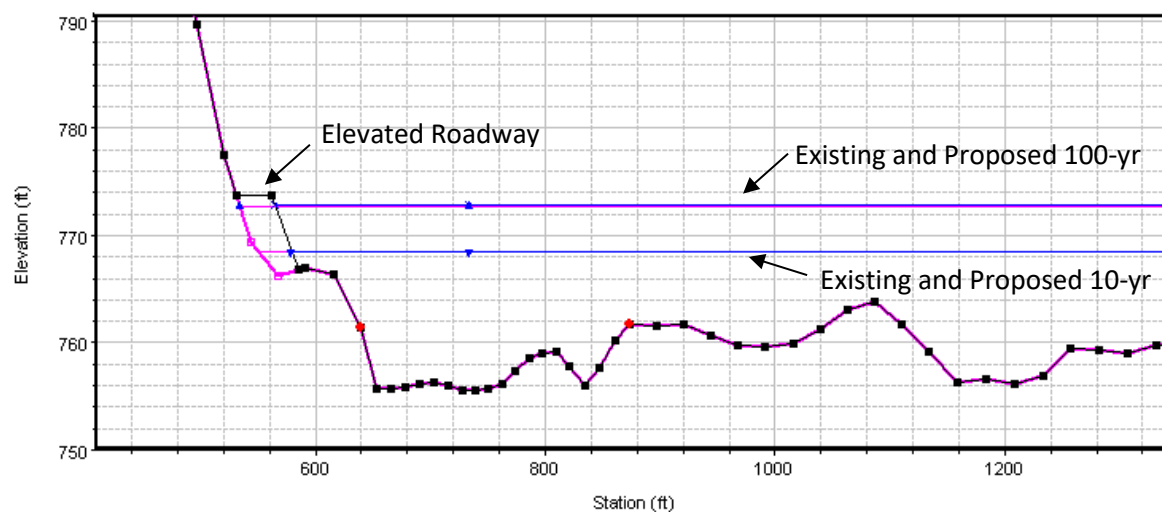
**Figure 4-17**  
**Cross Section View of Schoharie Creek**

Based on hydraulic analysis, the fill associated with raising the road would have a negligible impact on flood levels. Figure 4-17 is a cross section view of Schoharie Creek showing the proposed elevation of Bear Ladder Road along the left side of the valley and the resulting 0.05-foot rise in water surface elevations during the 100-year flood event.

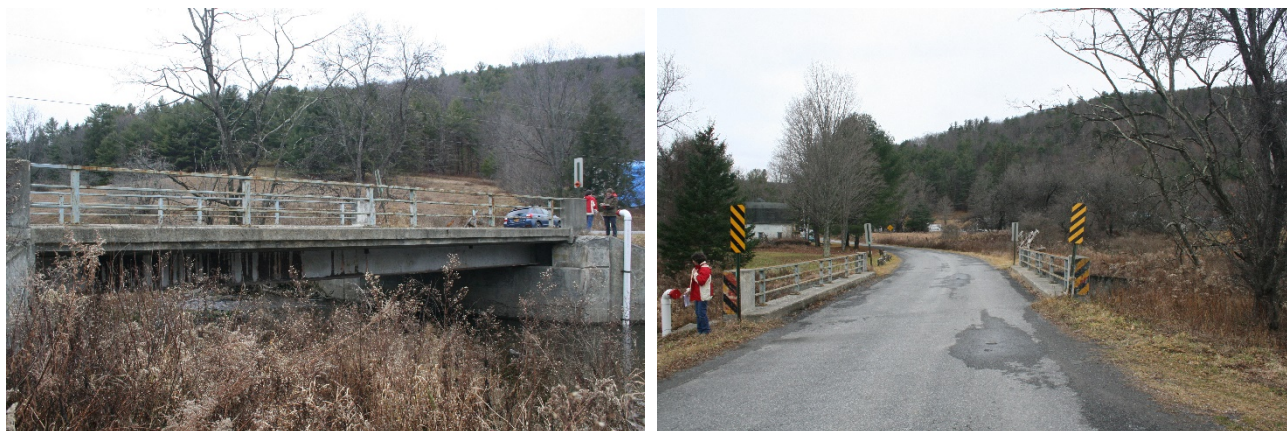
**Figure 4-18**  
**Photos of Patria Road Bridge**

Patria Road crosses over House Creek approximately 40 feet upstream of its confluence with Panther Creek (Figure 4-18). The bridge at this location reportedly becomes jammed with debris. According to the Schoharie County Department of Public Works, the dry hydrant pumpout located at Patria bridge was washed out during Tropical Storm Irene and was subsequently reinstalled. The bridge opening is 44 feet wide, with a 6.5-foot vertical distance between the bridge footing and the low chord on both sides. The channel along the left side of the bridge is somewhat scoured, resulting in the channel bed being 1 foot lower than the footing. The right side has a vegetated channel bar that covers the footing by approximately 1 foot, resulting in a distance of 5.5 feet between the top of the bar and the low chord. The bridge deck has a vertical height, or thickness, of 3.5 feet between the low chord and the base of the railing. The railing is open. The deck of the bridge is 24 feet wide. The channel substrate under the bridge is predominantly gravel with an area of sand. Sand is dominant moving downstream approaching the confluence with Panther Creek.

The bankfull width of House Creek measured in the vicinity of the bridge was found to be in the range of 50 to 55 feet. This is in close agreement with the regional regression equations utilized by *StreamStats*, which indicate a bankfull width of 55.8 feet.

*Patria Road bridge over House Creek viewed from downstream (left photo) and looking east along Patria Road (right photo)*

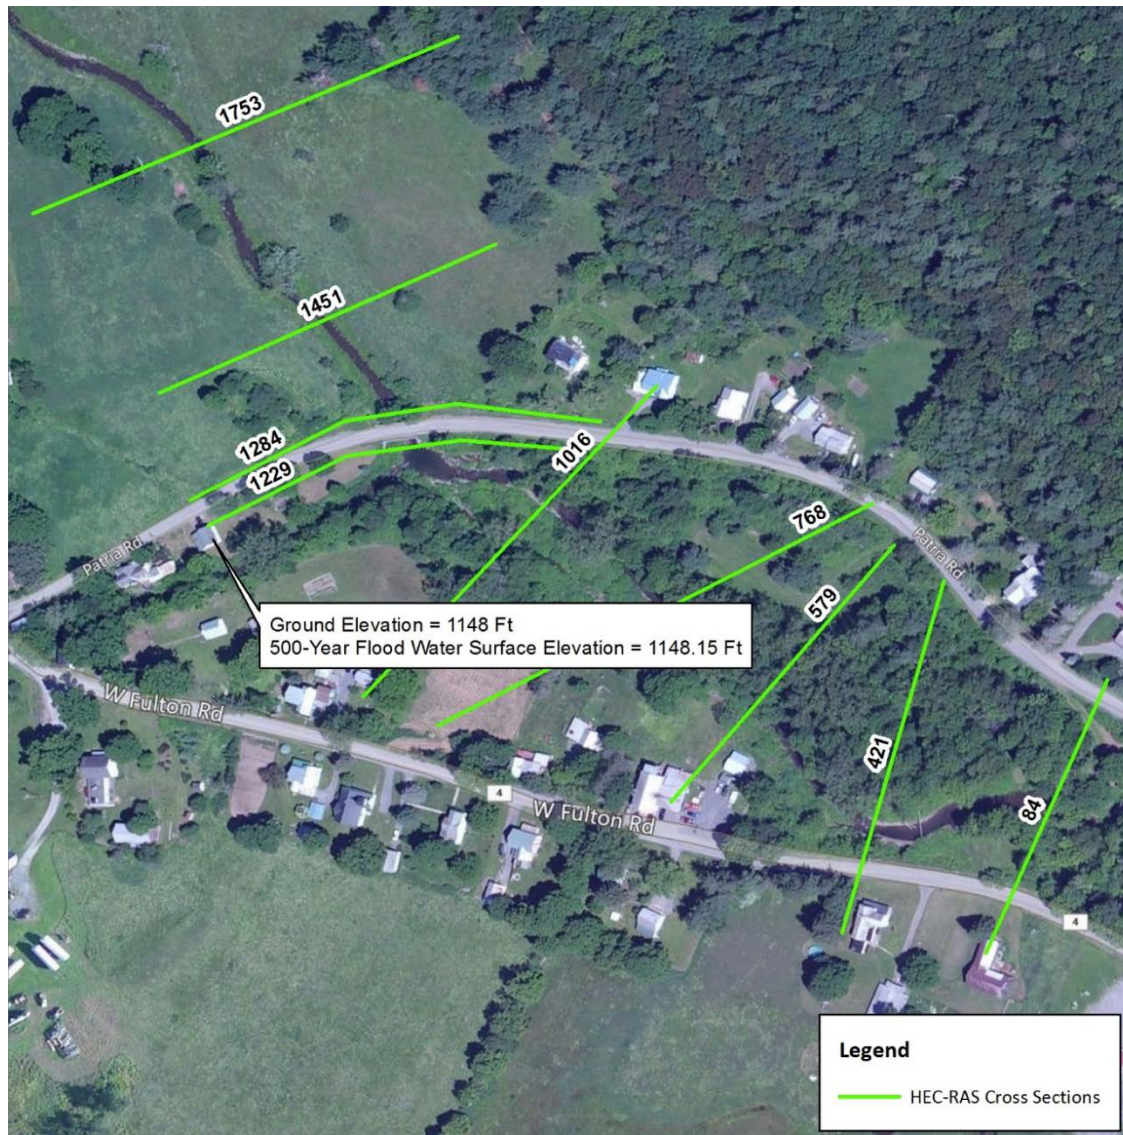
**Figure 4-19**  
**Aerial View of Patria Road Bridge**

elevation of 1,148 feet based on the 2014 LiDAR as shown in Figure 4-19. According to the HEC-RAS model, this building could experience minor flooding at an elevation of 1,148.15 feet in the 500-year flood without debris blockage. The buildings east of the bridge are at a higher elevation and would not experience flooding in the 500-year flood event.

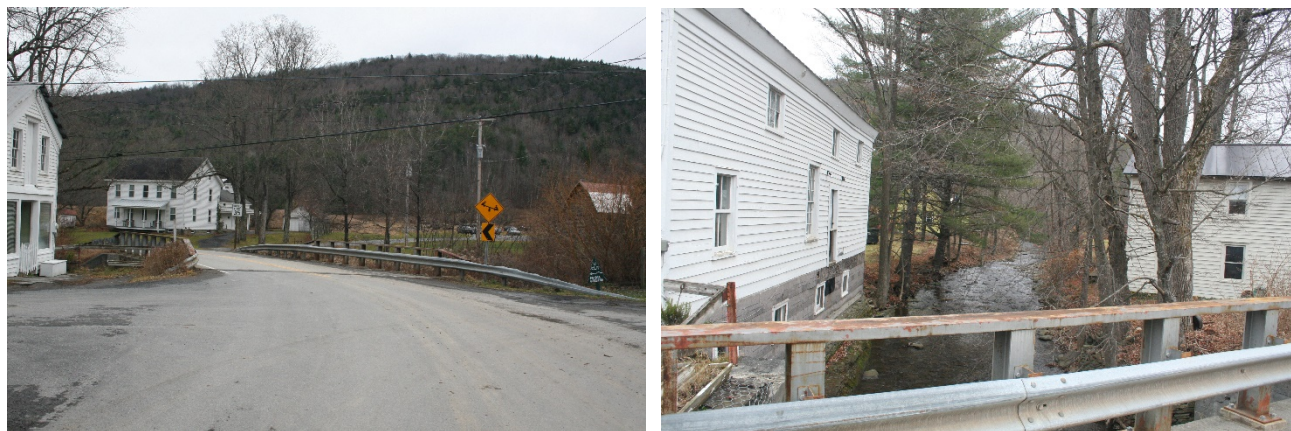
**Figure 4-20**  
**Photos of West Fulton Road Bridge**

The West Fulton Road (County Route 4) bridge over Panther Creek was also identified as being prone to debris jams and overtopping during flood events (Figure 4-20). The bridge crosses the creek at a skew and has a hydraulic opening that measures 26 feet in width with a maximum height of 8 feet when measured from channel thalweg to low chord. When measured from the top of a gravel bar along the right bank to the low chord, the opening height is 5 feet. The bridge deck is approximately 2 feet thick. The travel lane on the bridge deck is 25 feet wide from edge to edge with open railings along both sides. A home is located very close to the edge of the creek along the left bank on the upstream side, and buildings are located very close to both banks downstream of the bridge.

With a hydraulic opening of just 26 feet, the West Fulton Road bridge over Panther Creek is undersized when compared to the bankfull width of 46.5 feet. When the bridge is slated for replacement, the structure should be widened to better match the bankfull width of the channel, and hydraulic analysis should be conducted to ensure that the bridge is adequately sized to pass large flood events.
