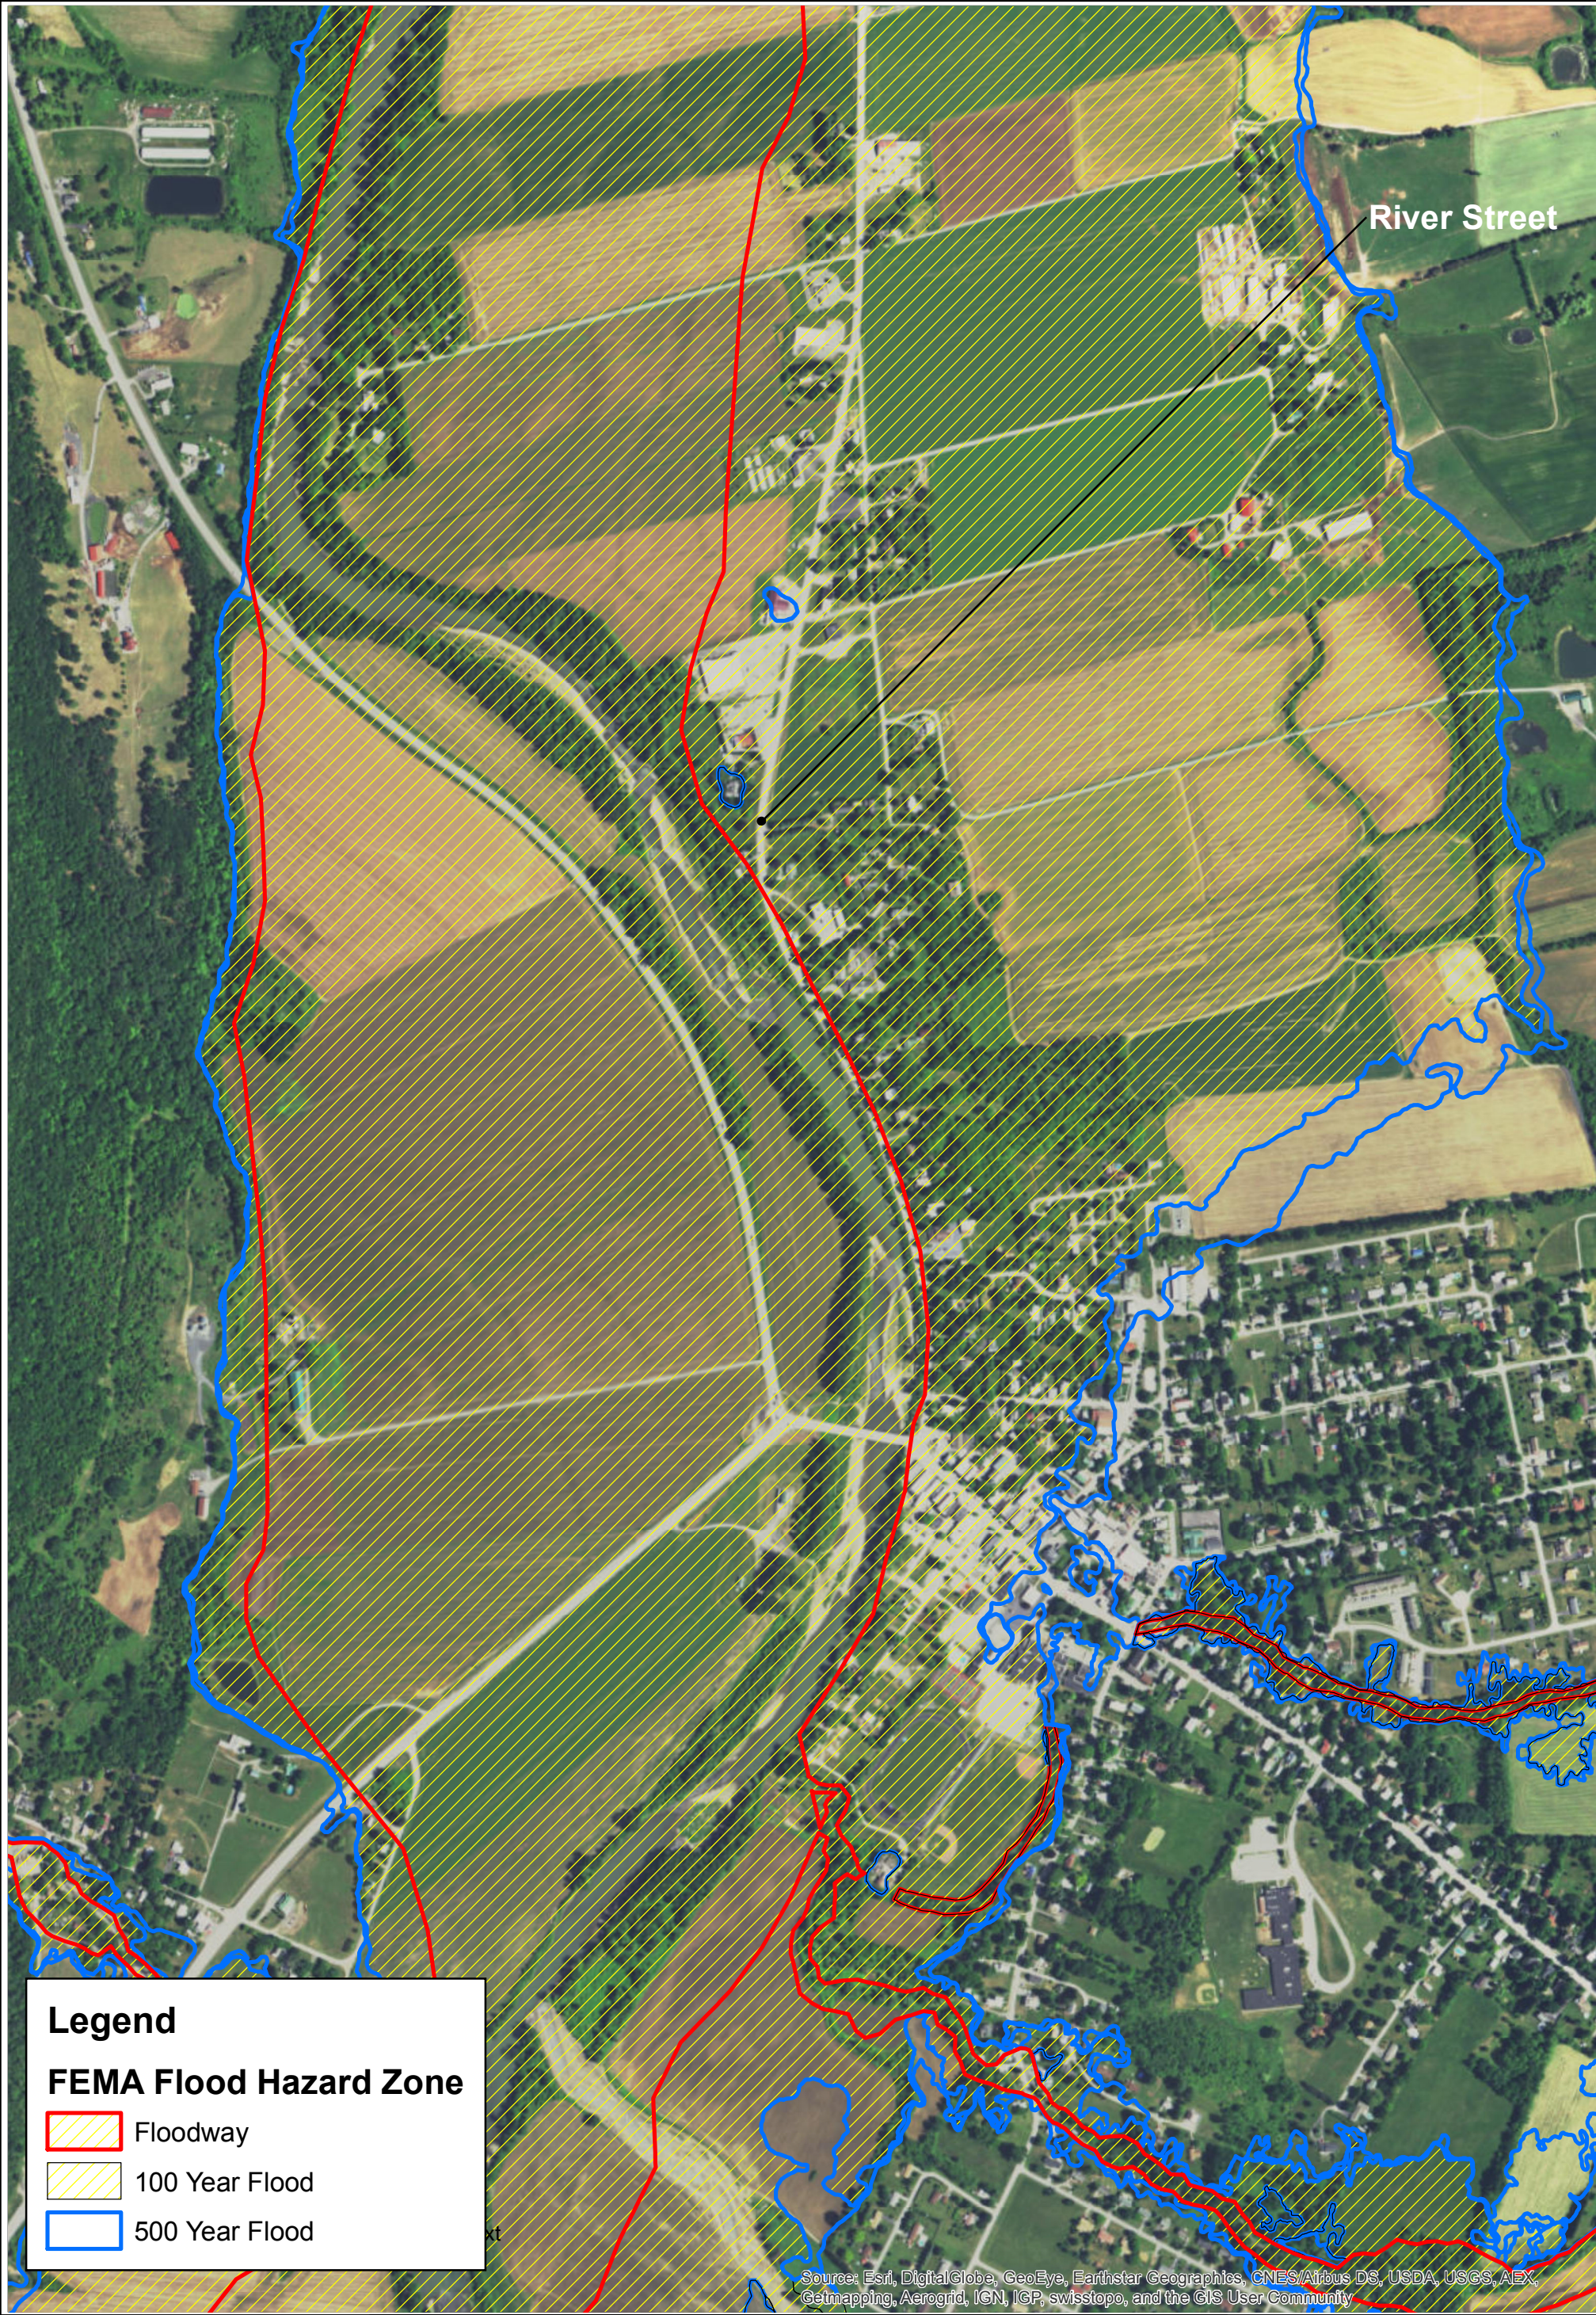
Figure 4-22 shows that many buildings along River Street in Middleburgh are located within the 100-year floodplain. River Street is lined with a mix of uses including single-family homes, community services such as churches, and a range of businesses. The businesses include a farm, stores, a mechanics shop, and a karate dojo as well as several abandoned businesses including the former Grand Union on the west side of the road closest to the river. Hydraulic modeling was used to predict flooding depths at various locations in Middleburgh during the 10-year and 100-year flood events. Table 4-6 presents a summary.

<p><b>SOURCE(S):</b></p> <p>NYS GIS Clearinghouse Orthoimagery (accessed June 2016)</p> <p>FEMA Schoharie County Special Flood Hazard Area</p>	<p><b>Figure 4-22: FEMA Flood Insurance Rate Map - Village of Middleburgh</b></p> <p><b>Schoharie Basin Flood Analysis</b></p> <p><b>Map By:</b> EMH <b>MMI#:</b> 4805-05 <b>MXD:</b> Q:\Projects\4805-05 Schoharie Basin Flood Analysis\GIS\MDX <b>1st Version:</b> 6/6/2016 <b>Revision:</b> 9/22/2016 <b>Scale:</b> 1 in = 667 ft</p>	<p><b>Location:</b></p> <p><b>Middleburgh, NY</b></p> <p><b>MILONE &amp; MACBROOM</b> 231 Main Street, Suite 102 New Paltz, NY 12561 (845) 633-8153 Fax: (845) 633-8162 www.miloneandmacbroom.com</p>
--	--	---

The area around the NYS Route 30 bridge and approximately 6,000 feet downstream was analyzed with hydraulic modeling. The existing conditions model shows that the NYS Route 30 bridge is overtopped during the 100- and 500-year floods. Modeling predicts that the bridge does not create a significant backwater under the modeled flow conditions and that replacement of the bridge with a wider or taller structure would not reduce flooding at nearby buildings.

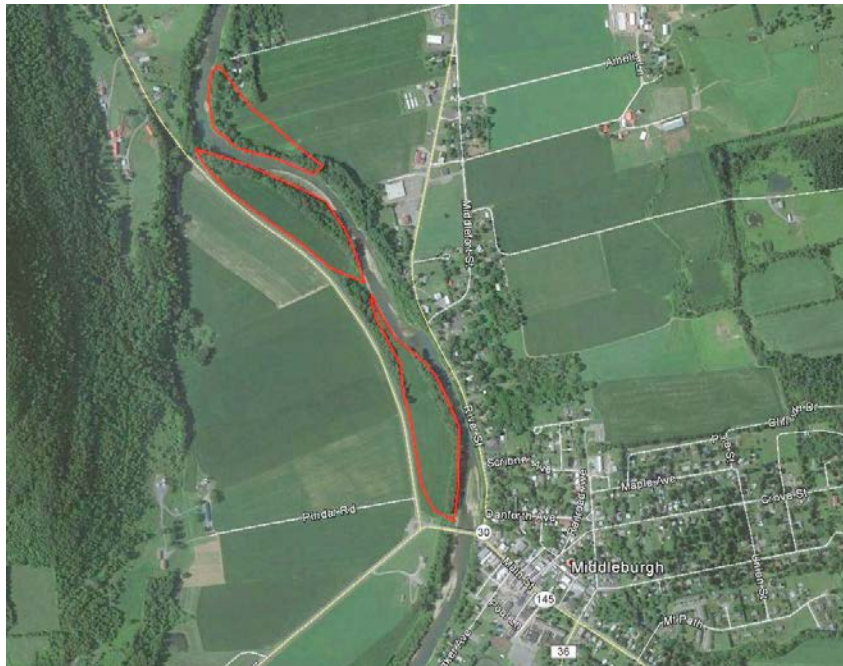
**Figure 4-23**

Hydraulic modeling was undertaken to evaluate several different floodplain enhancement configurations along the floodprone section of Schoharie Creek as it flows through Middleburgh. Floodplain enhancement scenarios were modeled within the agricultural fields along the left bank between Schoharie Creek and Route 145 and along the right bank where River Street bends away from Schoharie Creek. Figure 4-23 depicts locations where floodplain enhancement scenarios were evaluated as shown in the red outlines.

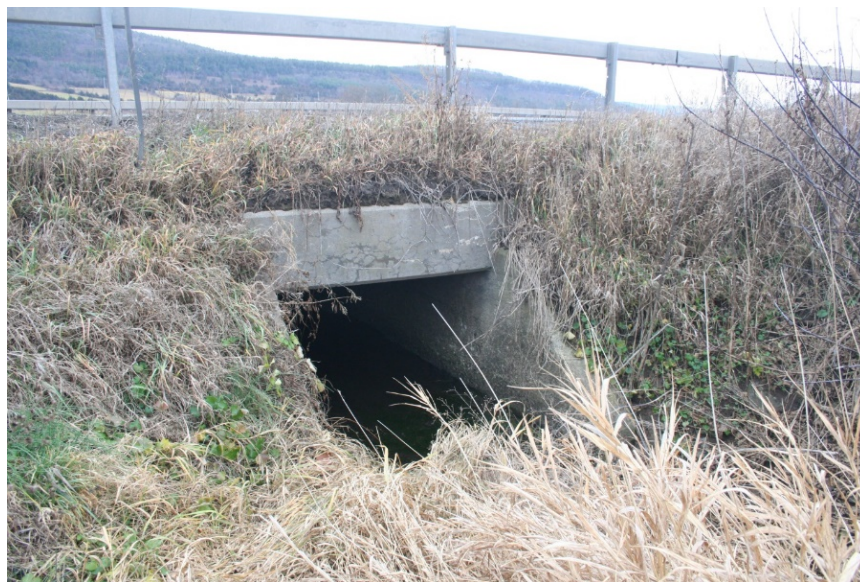
**Figure 4-28**  
**Inlet of culvert under NYS Route 30 south of Christmas Tree Lane**

Schoharie Creek flows across a wide, flat-bottomed valley with an extensive floodplain as it flows under NYS Route 30 in the vicinity of Christmas Tree Lane. At this location, the FEMA 100-year floodplain is approximately 1.6 miles wide. According to FEMA's FIRMs, NYS Route 30 in this area is extensively flooded during the 100-year event. As depicted in Figure 4-28, the culvert is a small concrete box 5.0 feet wide by 3.2 feet high and 40 feet long. The watercourse passing through the culvert under NYS Route 30 is a grass swale. Figure 4-29 depicts the FEMA floodplain at the culvert. The USGS *StreamStats* program was utilized to gather hydrologic information at this location. Table 4-7 presents peak flows.

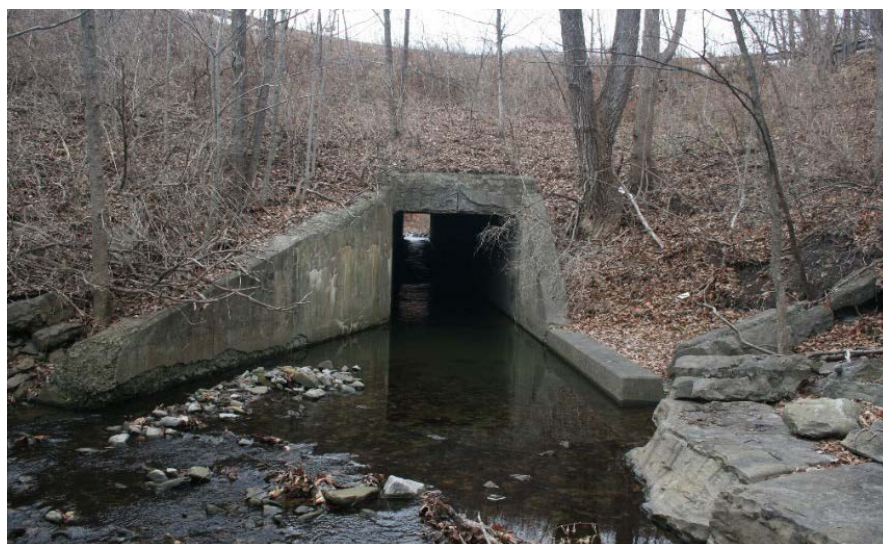
**Figure 4-30**  
**Downstream face of culvert passing beneath NYS Route 145**

Based on observations and field measurements, the Route 145 culvert is a concrete box with a slope of approximately 3.0 to 3.5 percent. Approximately 22 feet of earth is present between the top of the culvert and the Route 145 road surface. The length of the culvert is 220 feet, with a rise of 10 feet and a span of 10 feet. The channel upstream and downstream of the culvert is tightly confined with no natural floodplain. The channel upstream of the culvert consists of cobble with no bedrock. The channel downstream of the culvert consists of exposed bedrock, boulder, and cobble.

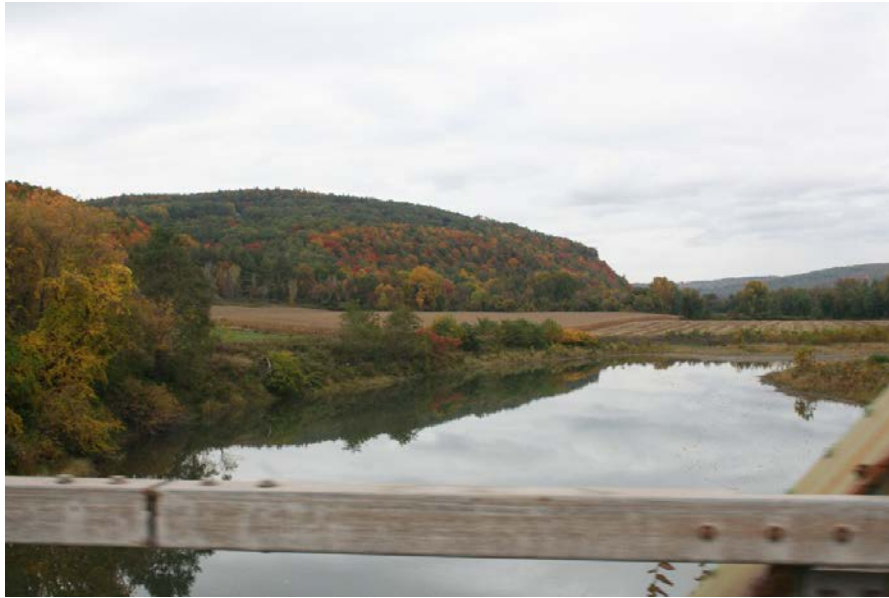
**Figure 4-32**

locations, the floodplain is close to three-quarters of a mile wide. According to the FEMA FIRMs, the village of Schoharie along Main Street is subject to inundation during the 100-year flood event as depicted in Figure 4-31. Figure 4-32 is a photograph taken from the Bridge Street bridge. The expansive flood zone associated with the 100-year flood event extends into the village of Schoharie, inundating portions of Main Street and affecting neighborhoods to the west of Main Street and portions of the village to the east of Main Street.

**View of Schoharie Creek and its broad floodplain looking downstream from Bridge Street bridge in Schoharie**

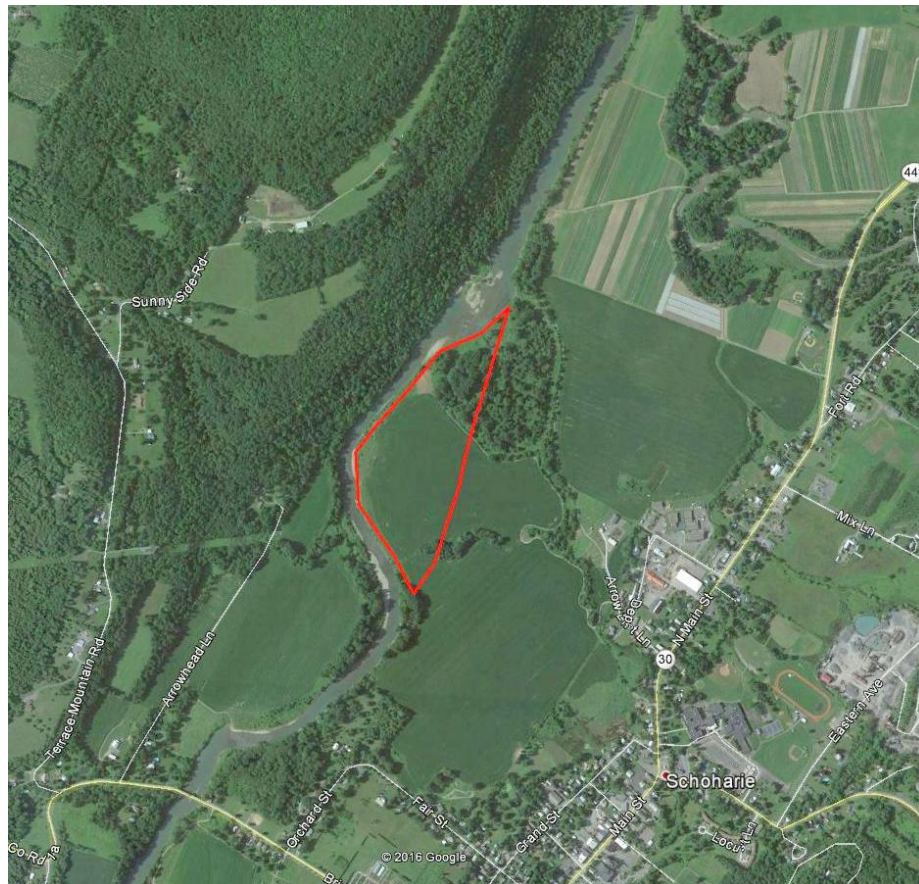
**Figure 4-33**

Many factors contribute to whether or not floodplain enhancement will result in a meaningful decrease in flooding and flood-related damages in nearby, inhabited areas. For this reason, it was necessary to conduct hydraulic modeling for a range of floodplain enhancement configurations along Schoharie Creek. One such configuration is illustrated in Figure 4-33, which shows a wide enhanced floodplain along the right bank of Schoharie Creek downstream of the Bridge Street bridge.

**Aerial view showing one possible configuration of an enhanced floodplain along the right bank of Schoharie Creek**
