Flood Mitigation Study

Schoharie Watershed

Contract #C1000449
Tasks 7-1 through 7-4

Schoharie, Albany, Montgomery, Otsego, and Schenectady Counties,
New York
April 2017

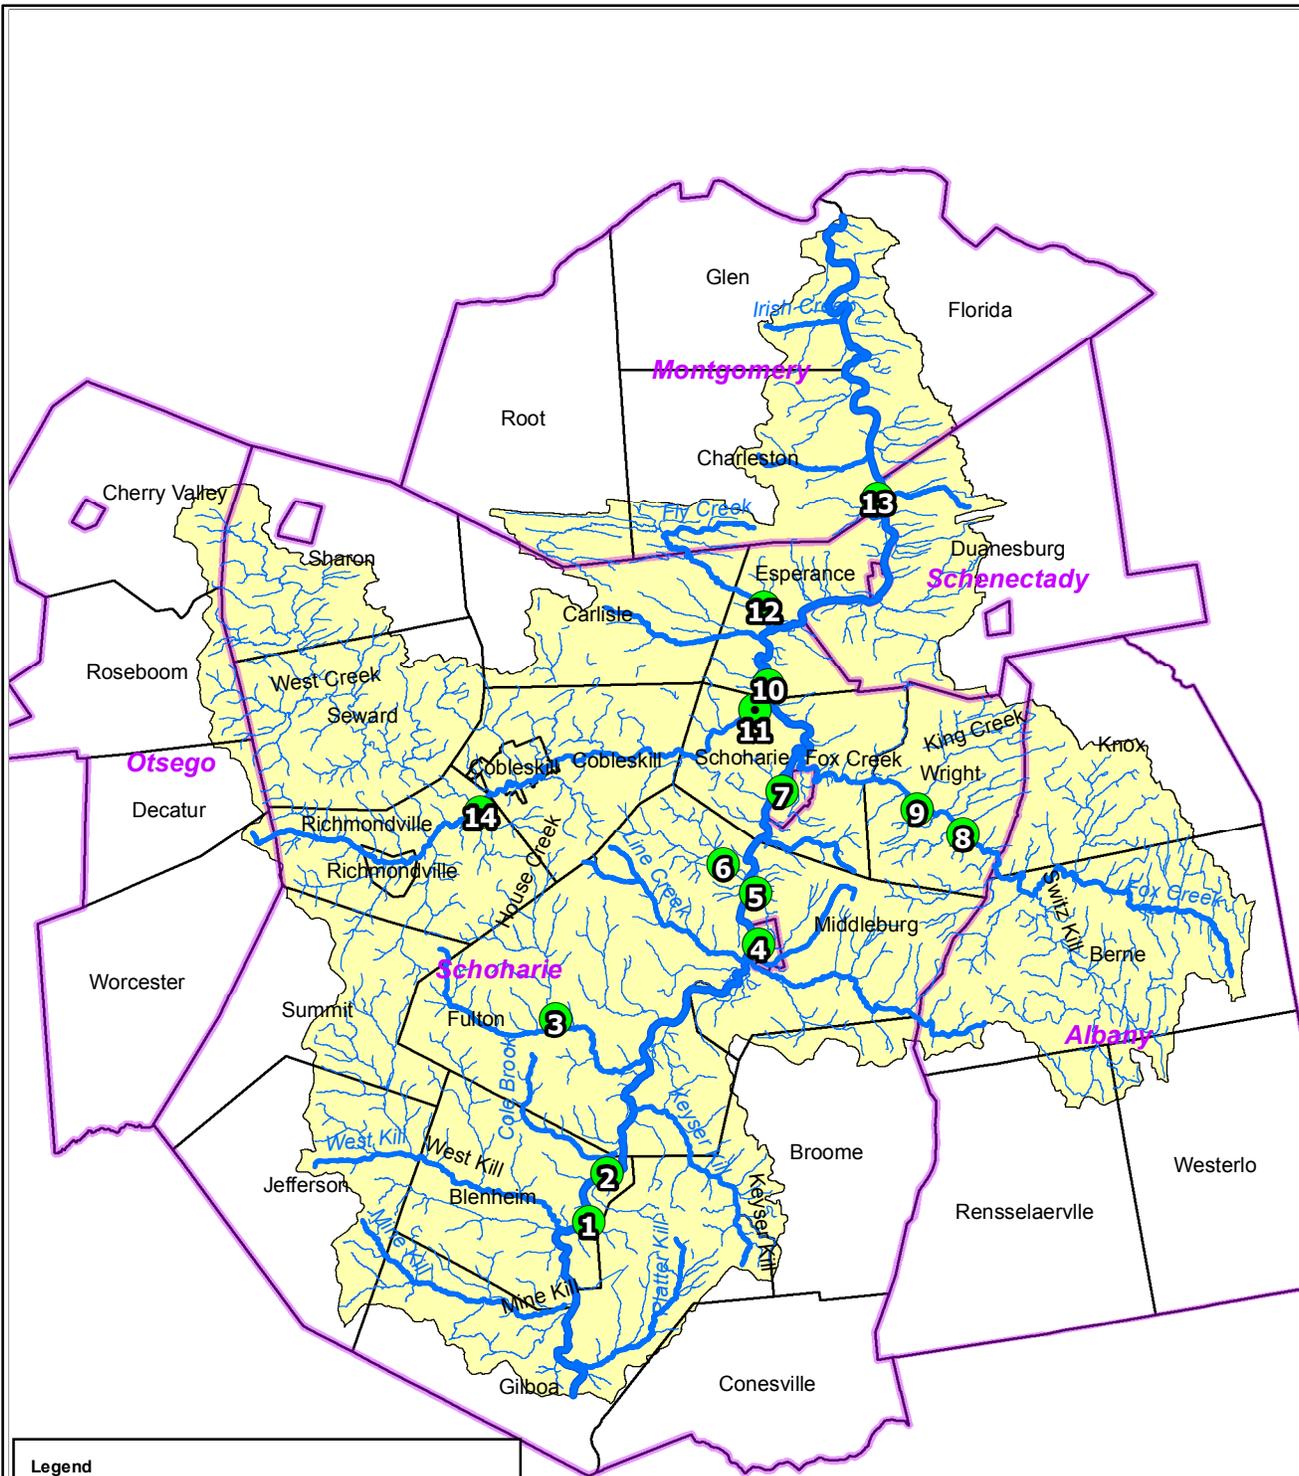
For the purposes of this assessment, 18 focus areas were identified within the Lower Schoharie Creek watershed. Fifteen of the focus areas are specific locations while the remaining three areas can be applied throughout the watershed. A greater level of information was collected for the focus areas in order to assess potential flood mitigation projects. Within each focus area, MMI staff conducted on-the-ground assessments and visual inspections, including identification of land uses and low-lying structures, assessment of bank and channel conditions, measurements of valley confinement, measurements of bridge and culvert openings, and assessment of vegetation along the stream corridors. For each focus area, a range of flood mitigation alternatives was developed and evaluated, and hydraulic modeling was conducted where appropriate. Alternatives were recommended for those alternatives that were found to provide substantial flood mitigation benefit at a cost that would justify their implementation.

1 - North Blenheim		8 - Fox Creek
	2 - Bear Ladder Road		9 - Gallupville
	3 - West Fulton Hamlet		10 Railroad Bridge in Esperance
	4 - Village of Middleburgh		11 - Cobleskill Creek Confluence
	5 - Christmas Tree Lane Culvert		12 - Fly Creek
	6 - Route 145 Culvert		13 - Colyer Road, Burtonsville
	7 - Village of Schoharie		14 - Warnerville Cutoff

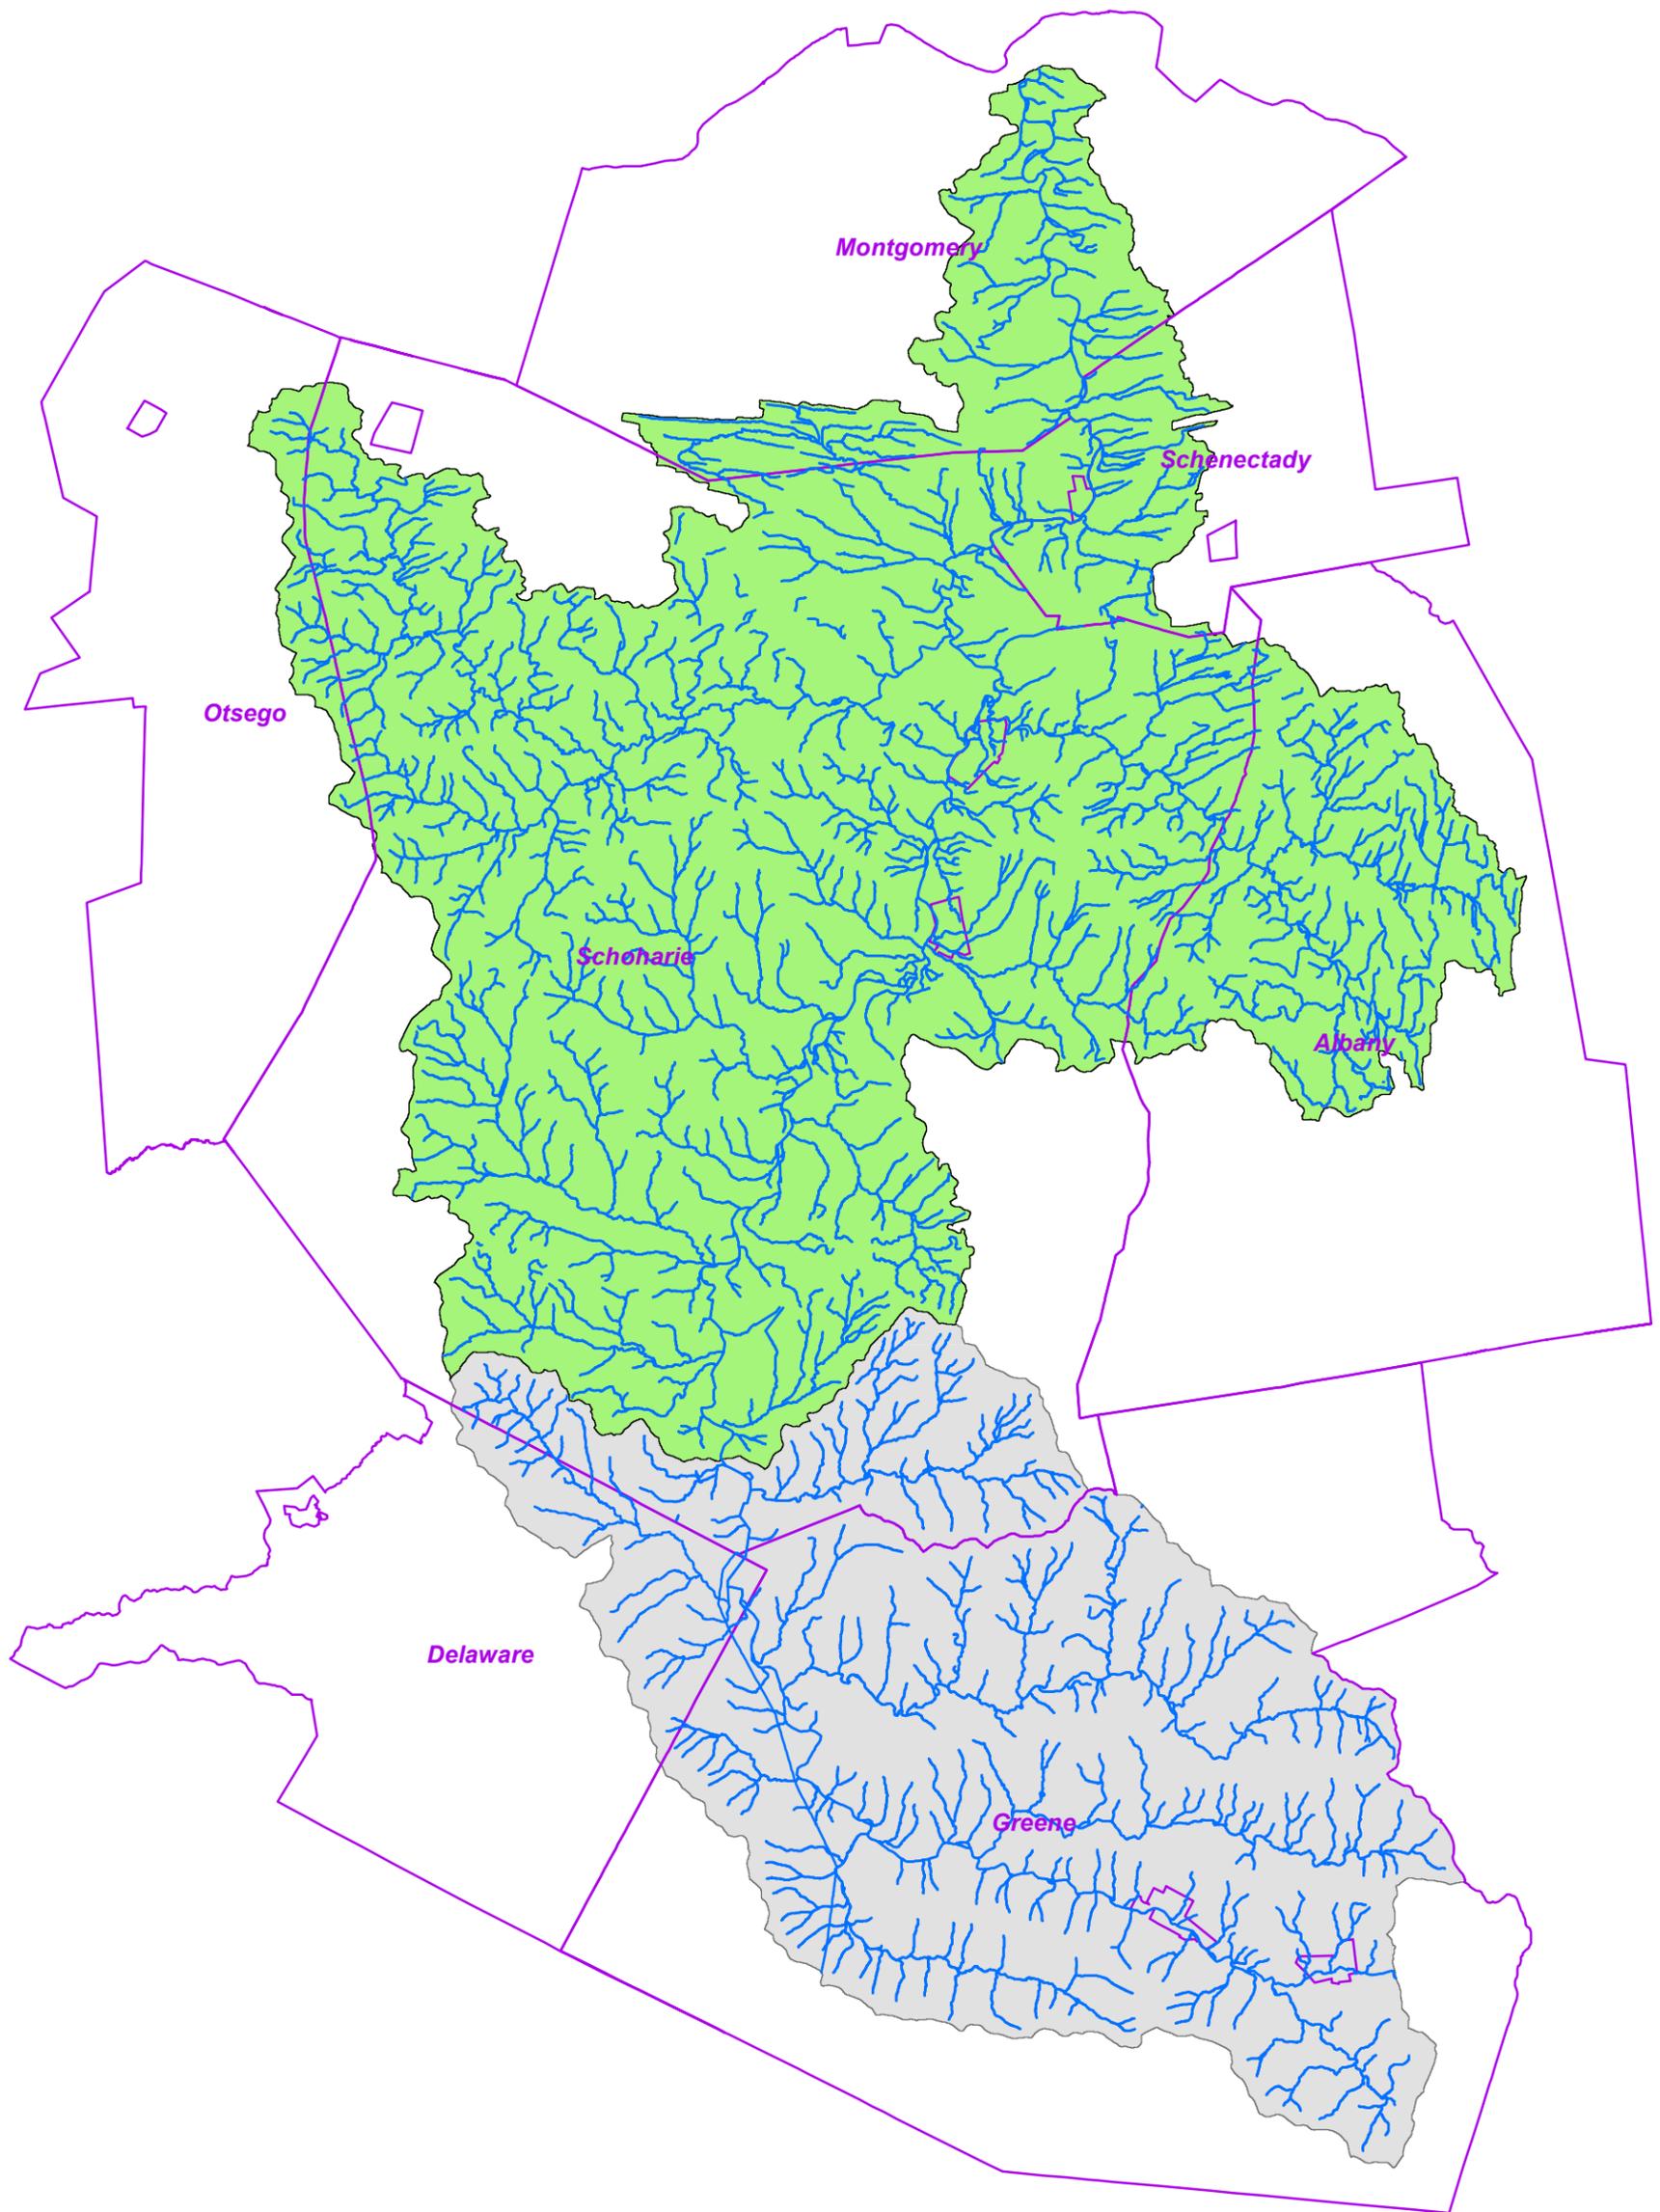
The Lower Schoharie Creek basin, comprising nearly two-thirds of the entire Schoharie Creek watershed, covers an area of 612 square miles and is 61 miles in length. The lower watershed extends into five counties, with the majority of the basin located within Schoharie County and small sections of the basin area located within Otsego County to the west, Montgomery County to the north, and Schenectady and Albany counties to the east. Figure 1-1 depicts the overall Schoharie Creek watershed and the Lower Schoharie Creek basin. Table 1-1 presents a list of the counties and towns that are located within the basin as well as the particular villages, hamlets, and place names that are referenced within this report.

The Schoharie Creek watershed includes numerous major tributaries as well as many smaller unnamed tributaries. The major tributaries are listed in Table 1-2. The course of Schoharie Creek includes two reservoir-dam systems: The Blenheim-Gilboa Dam, which is owned by the New York Power Authority (NYPA) and used to produce hydroelectric power, and the Schoharie Reservoir, a part of the New York City Water Supply System (FEMA, 2012 - Schoharie County Flood Insurance Study [FIS]).

- Streams
- Lower Schoharie Creek Project Basin
- Upper Schoharie Creek Watershed

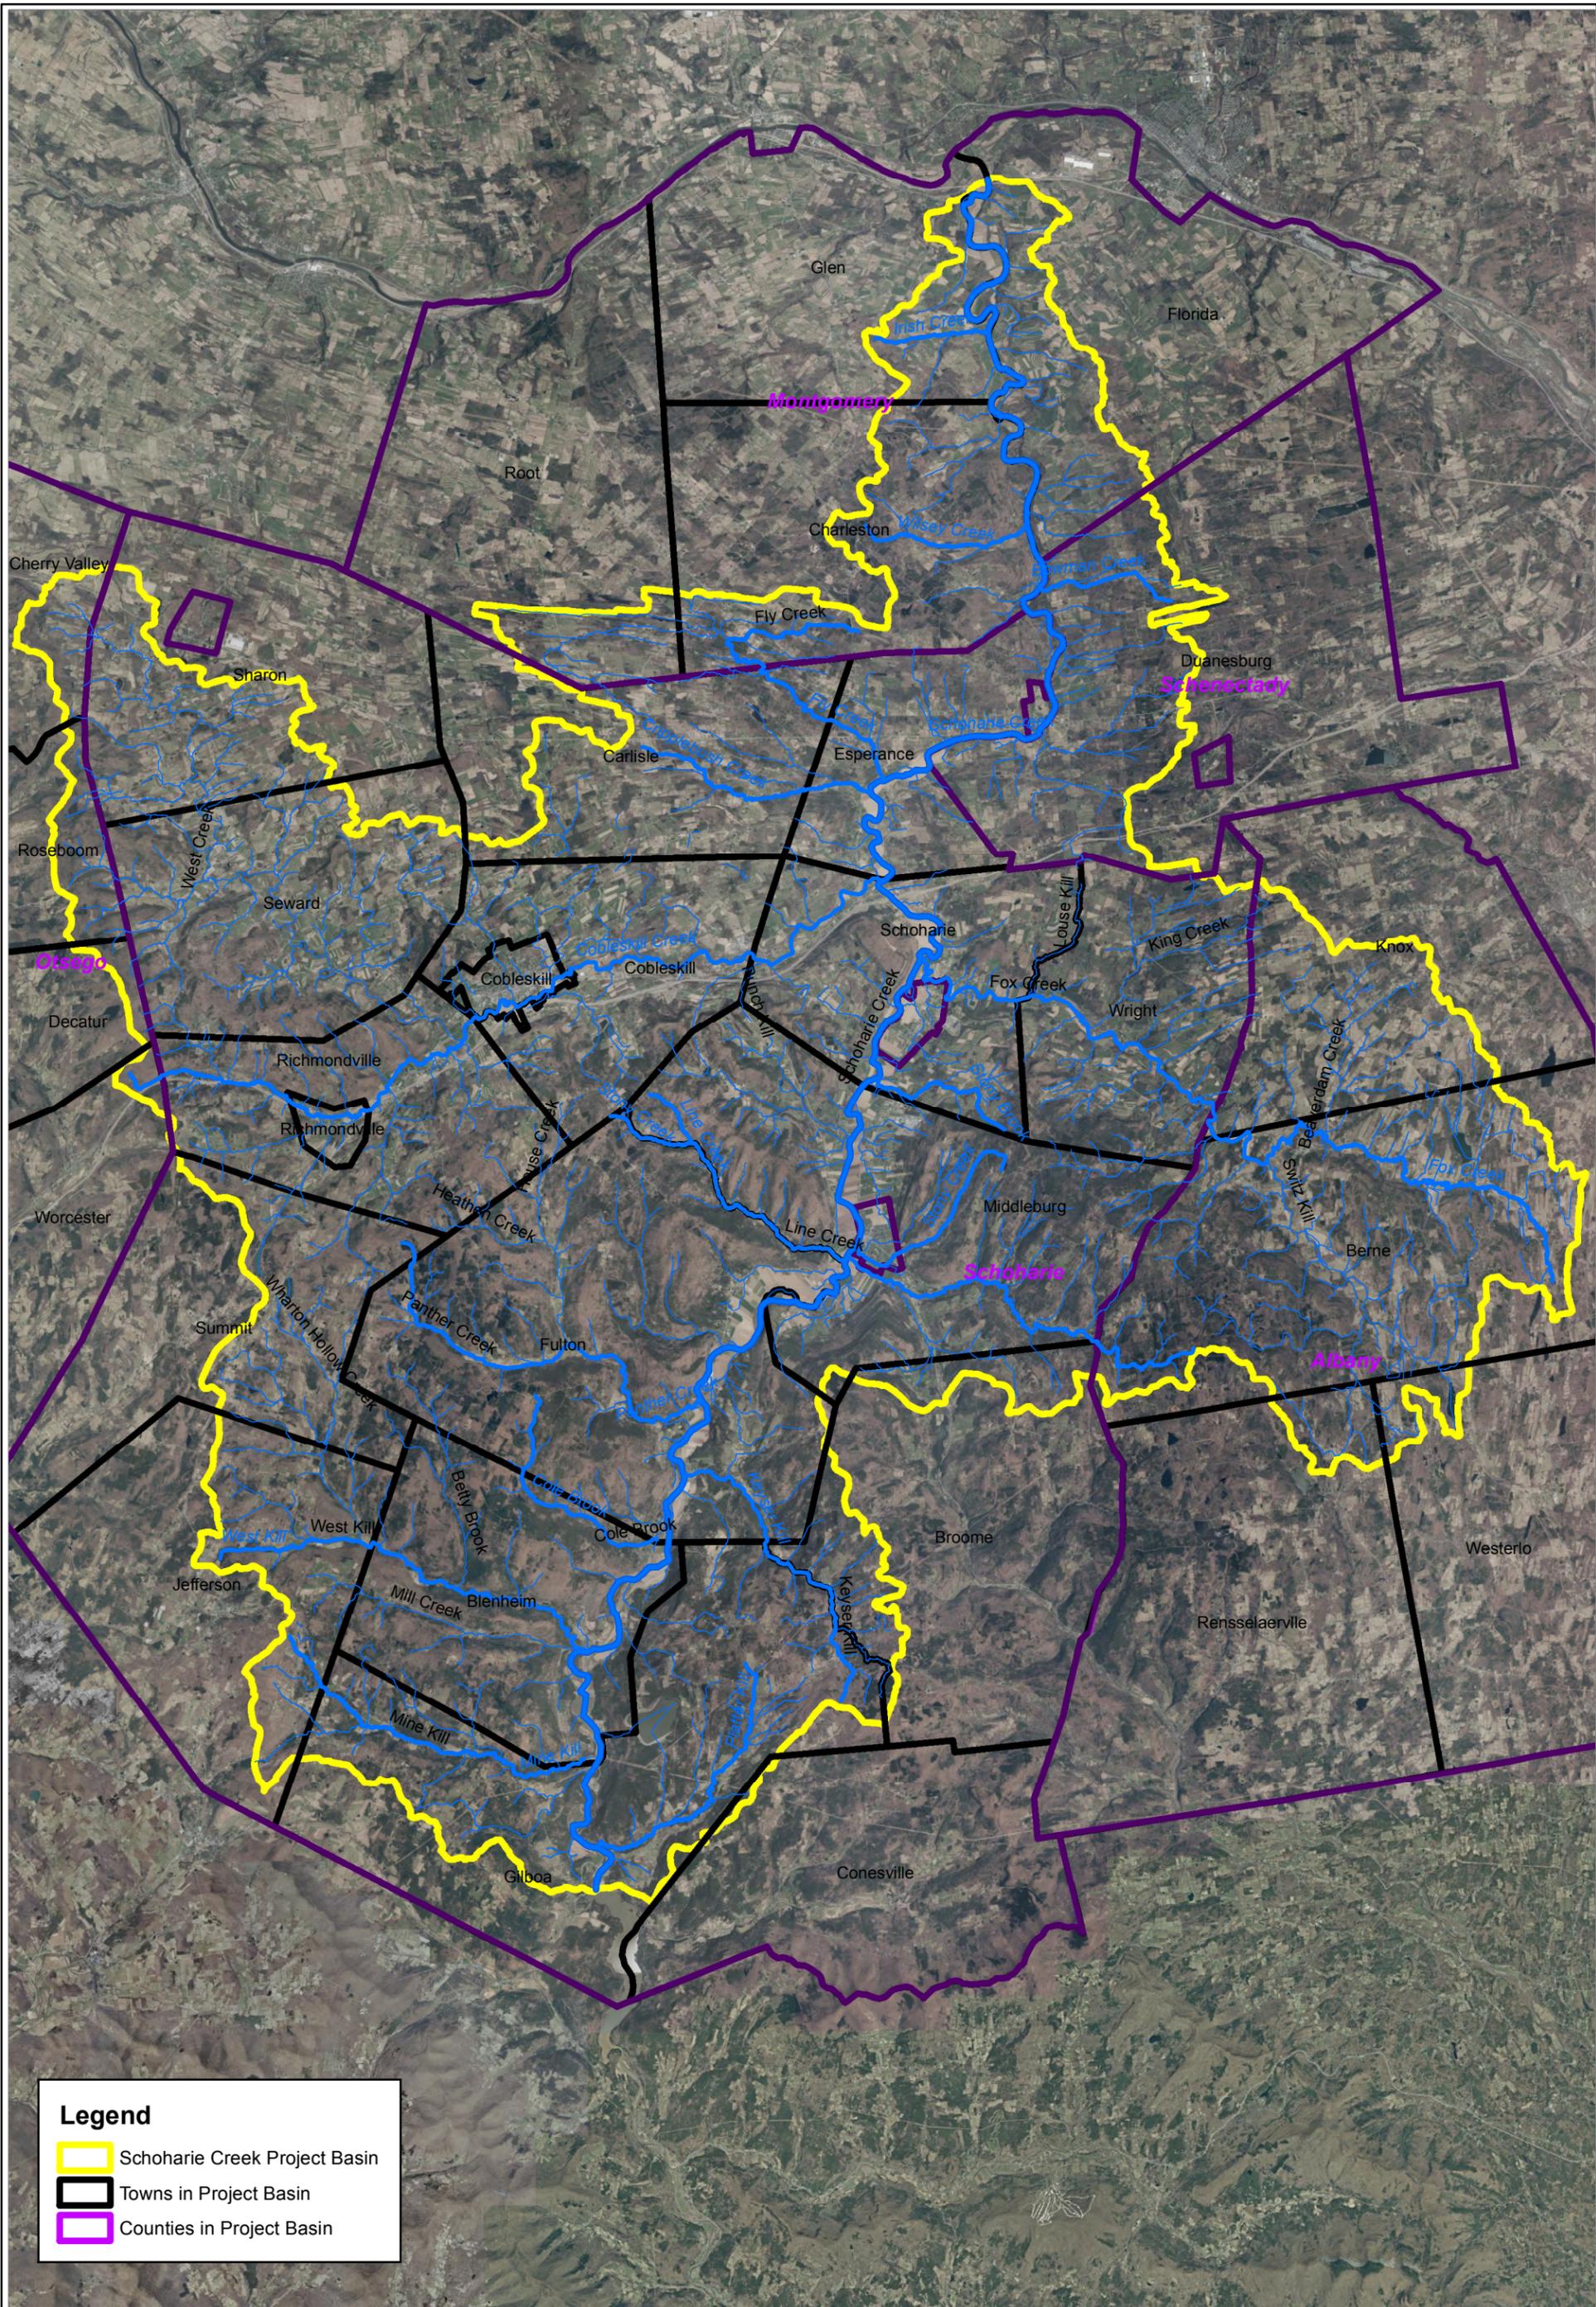
Figure 2-1 is a watershed map of the Lower Schoharie Creek watershed. Schoharie Creek flows through or borders 10 towns including the towns of Gilboa, Blenheim, Fulton, Middleburgh, Schoharie, Esperance, Duaneburg, Charleston, Florida, and Glen. The Lower Schoharie Creek drains an area of 612 square miles and outlets into the Mohawk River at a point 61 miles downstream of the Gilboa Dam. The Schoharie Creek basin is 76 percent forested (*StreamStats*, 2015) with a mix of agricultural uses located primarily in the river valley, residential and commercial land uses concentrated in and around the hamlets, and rural residential uses outside of the hamlets.

- Schoharie Creek Project Basin
- Towns in Project Basin
- Counties in Project Basin

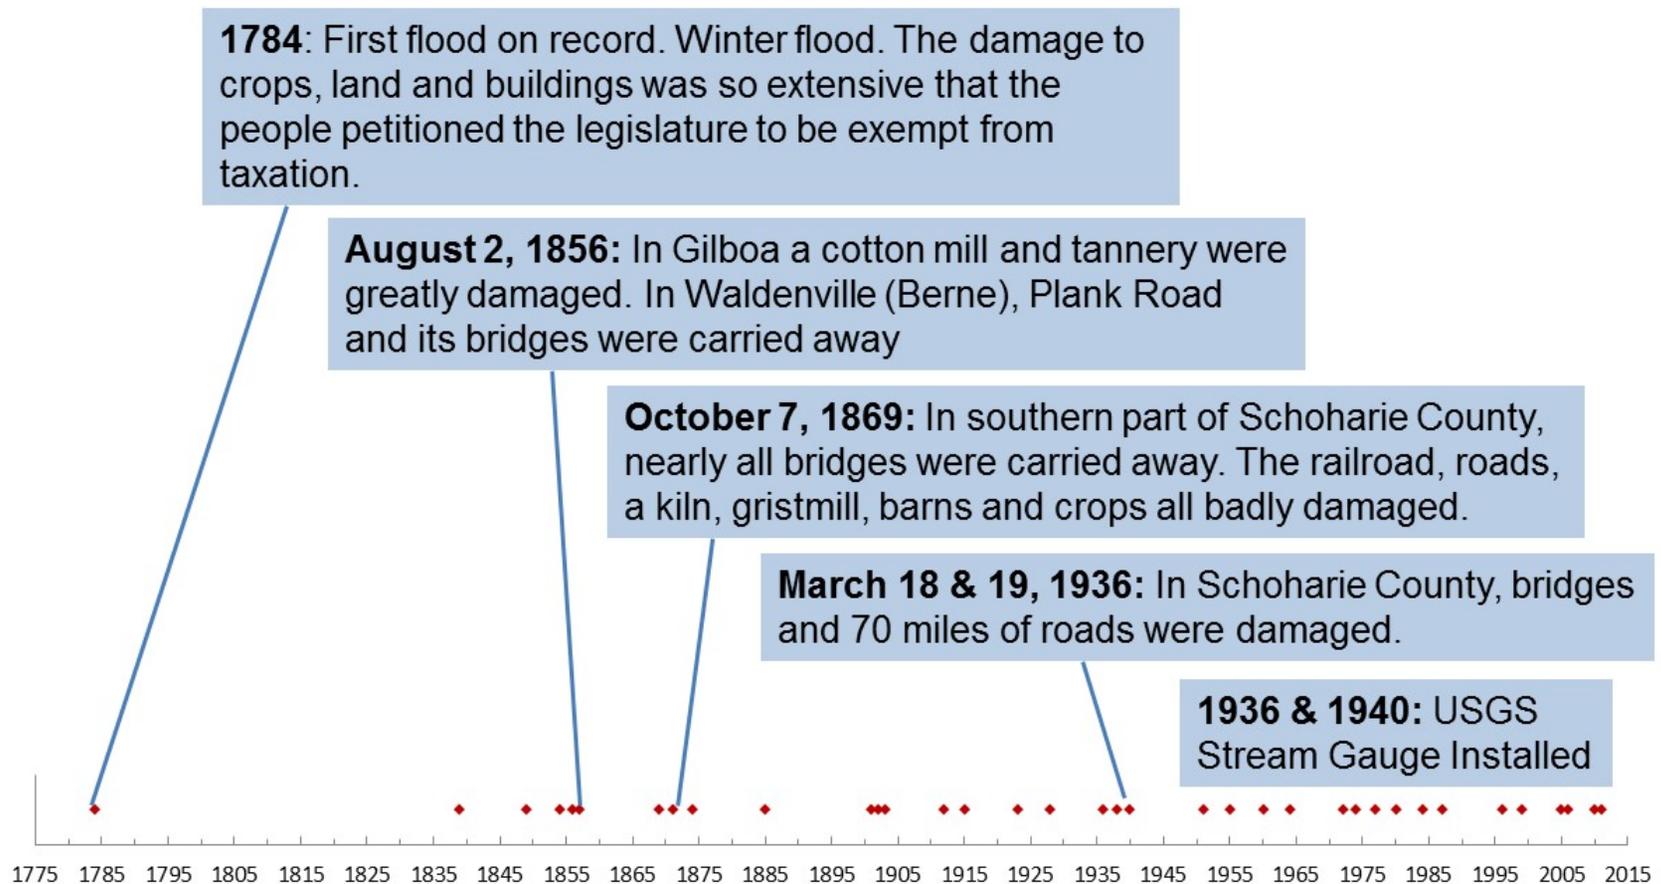
Figure 3-1

Time line created from flood information in *History of Schoharie County Floods, 2012*. Schoharie County Historical Society

On **June 7, 1874**, flooding was reported in many locations within the basin, including in the upper section of Blenheim Village. The Westkill floodwater levels were very high and carried off a mill dam and bridge, a shoe shop, a house and barn, and another house (and 86 beehives). A tributary of the Westkill carried away a saw mill. Also washed away were bridges, mill dams, and roads in many places.

On **December 15, 1901**, the Schoharie River reached its highest levels in 32 years, and according to historic reports, this flood was second only to the 1869 flood. In Schoharie Village, the flats were flooded, the railroad tracks were covered, and cellars were filled. Bridges and roads were damaged or destroyed throughout the basin.

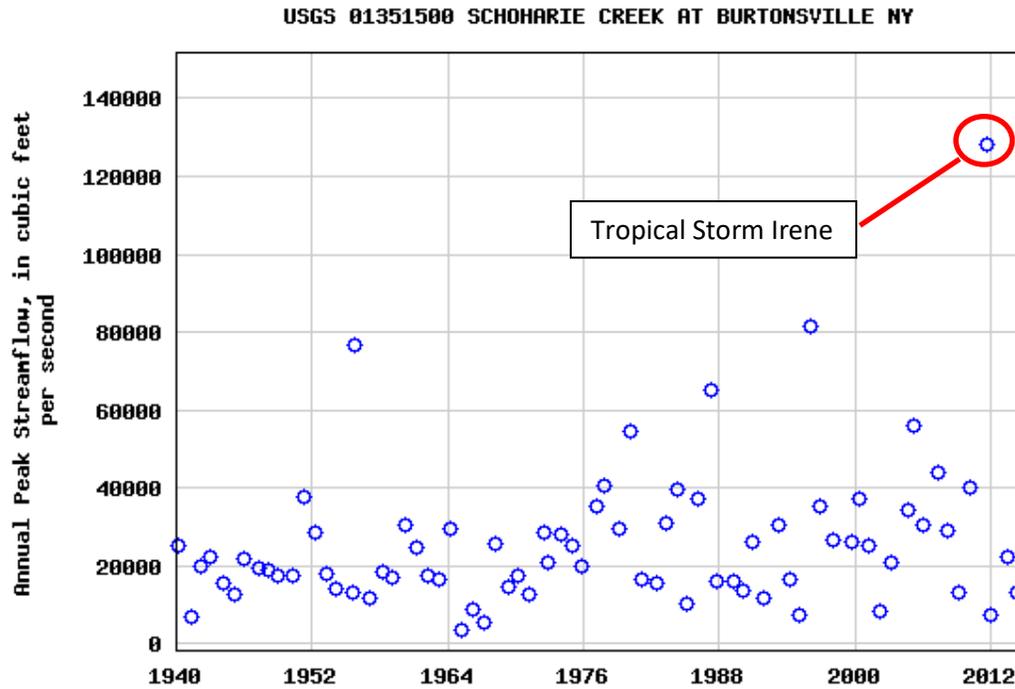
Figure 3-2
Annual Peak Discharge - USGS Gauge #01351500 at Burtonsville, NY

Figure 3-2 presents annual peak flows recorded at USGS gauge #01351500 Schoharie Creek at Burtonsville, NY, between 1996 and 2014. According to a USGS report (2014), the HWM was surveyed in 184 locations along Schoharie Creek (upper and lower basins), and the HWM in the lower reaches of the basin exceeded those published by FEMA for their respective 0.2-percent (500-year) flood events. In addition, the USGS report noted that peak discharges exceeded their 1-percent (100-year) flood discharge at 25 stream gauges and their respective 0.2-percent (500-year) discharges at six sites in the Schoharie Creek basin.
